Effect of Center Pivot System Lateral Configuration on Water Application Uniformity in an Arid Area

H. M. Al-Ghobari¹

ABSTRACT

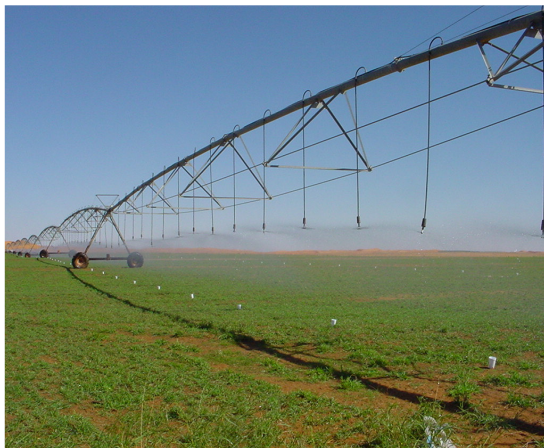
(a) Original lateral

Figure 1. Two types of center pivot systems employed in the study with (a) original and (b) modified laterals.

The original pivot lateral (Figure 1-a) within these center pivot systems was built of galvanized steel pipe (Table 1), while the center pivot systems with modified laterals (Figure 1-b) carried a polyethylene pipe of the same diameter all through and positioned below the original lateral. The height of the modified lateral was close to the soil surface as compared with the original lateral with the new height from soil surface ranging between 1.5 and 2.0 m, and the lengths of the drop tubes connected to the modified lateral ranging from 0.5 to 1.0 m. none of the sprinklers, installed along the modified lateral were equipped with pressure regulators.

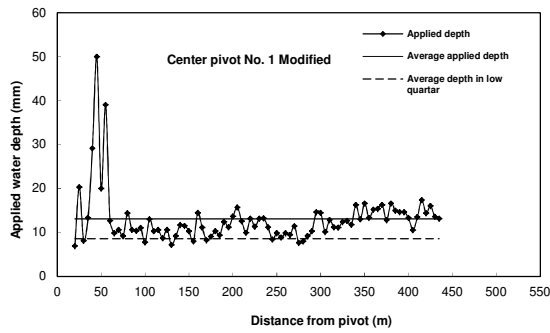
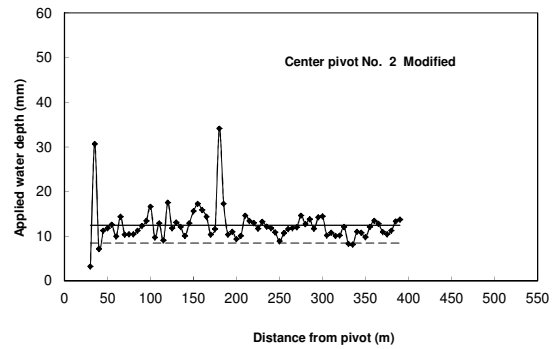
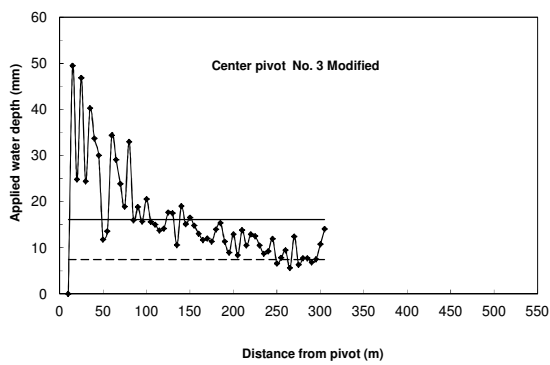
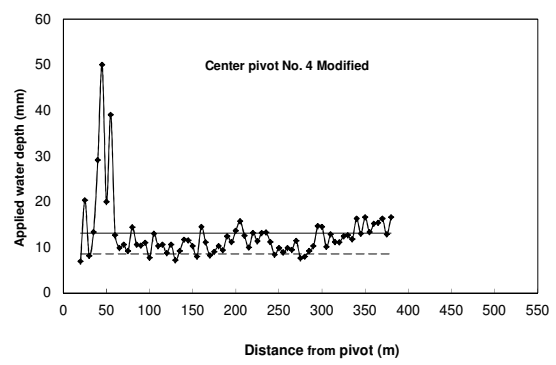
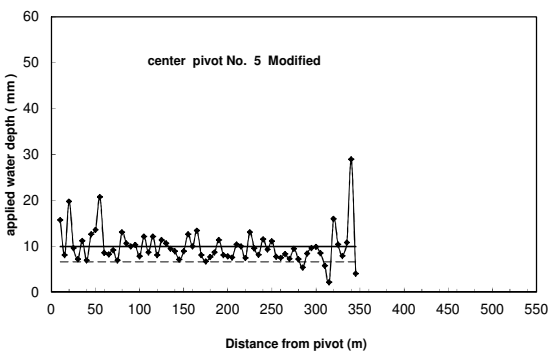
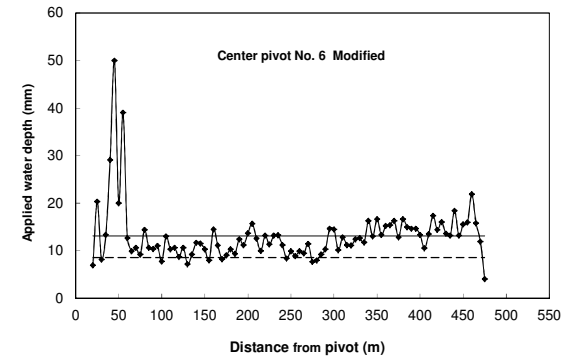
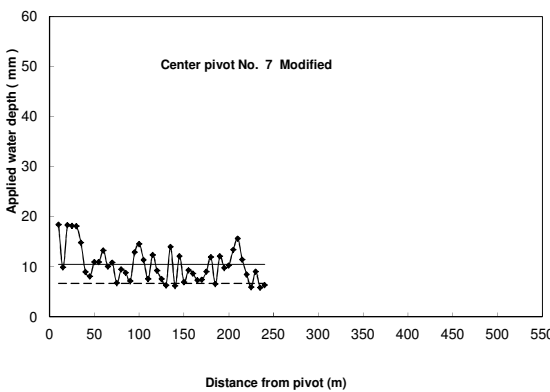
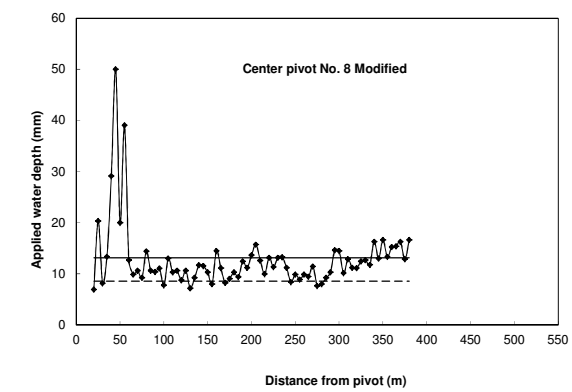
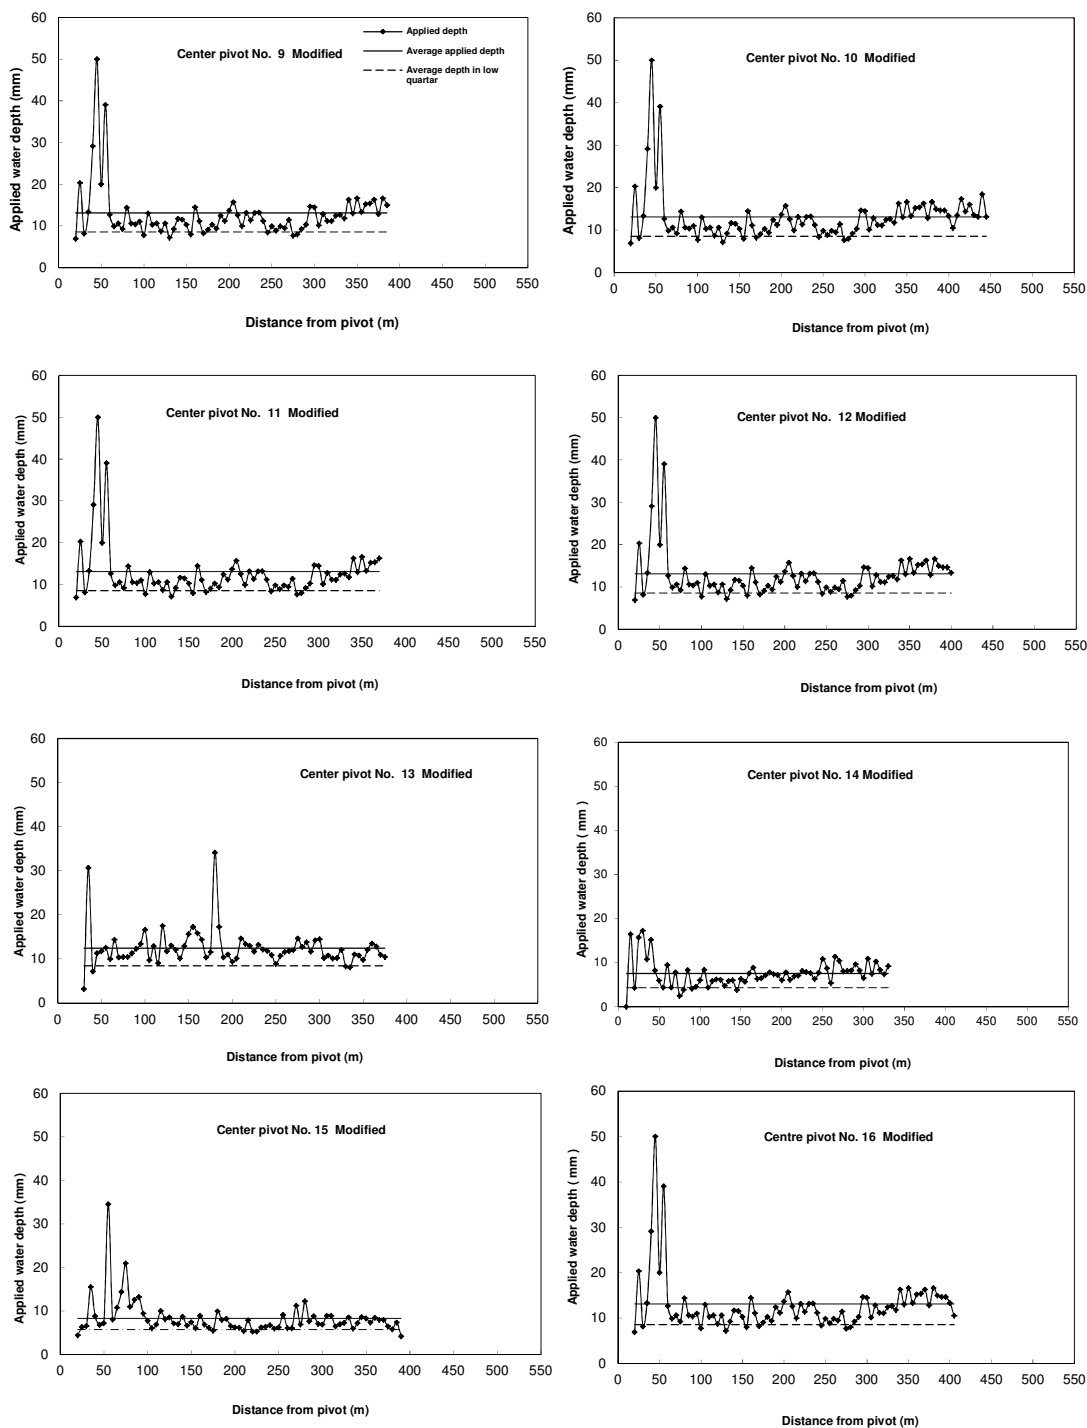
Figure 4. Water distribution patterns in radial direction with the average depths and the average low quarter depths of application recorded from center pivot systems with modified laterals.

Water application uniformity is a measure of how evenly water is spread over the soil surface during irrigation under different field operating conditions. Water distribution profiles along the laterals of the tested center pivot systems are shown in Figures 3 (a and b) and 4 (a and b) for original and modified laterals, respectively. The profiles depict water depths caught in each can along the lateral for each of the 32 center pivot

systems. The figures show that substantial areas of the center pivot systems were receiving less than the average amount of water applied and there was substantial variation in depth of water applied along the lateral from one system to another, especially for center pivot systems with modified laterals. Average depths and average low quarter depths of application for each system were determined and displayed (Figures 3 and 4). Average depths and the low quarter average depths of application for 24 center pivot systems equipped with original laterals ranged from 24.33 to 4.31 mm, and from 17.42 to 2.33 mm respectively, whereas, the average depths and the low quarter average depths of application for the 24 modified systems (Figure 4) ranged from 13.23 to 5.23 mm and from 9.36 to 3.59 mm respectively. It can be seen that both depth values for the original systems were higher than those for modified systems. This indicates that more water was applied through the original center pivot systems to the irrigated areas as compared with the center pivot systems with modified laterals and when at the same travel speed. The lower depth values were attributed to lateral configurations changes made by farmers, bringing about pressure variations, improper nozzling, inaccurate water patterns and as well leakage along the laterals.

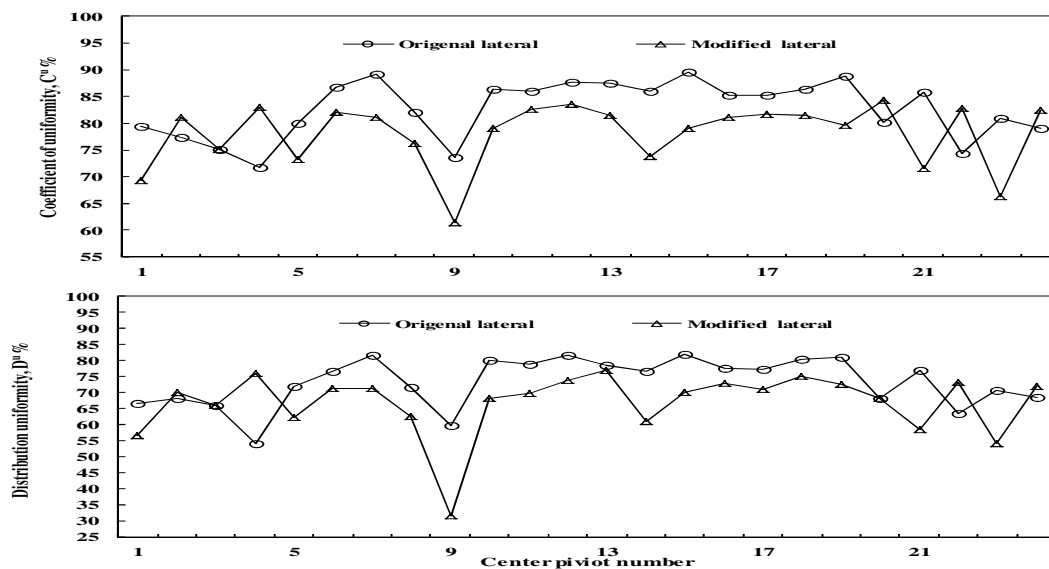
Figure 5. A comparison between values of coefficient of uniformity (C_u) and distribution uniformity (D_u) for 48 of the original vs. modified center pivot systems.

To compare how well the center pivot irrigation systems applied water to the irrigated areas and to determine whether each system was operating at an acceptable uniformity, performance index values were determined and compared. This was done by calculating the values of C_u and D_u , employing Equations (1) and (2) for the 48 center pivot systems. A comparison of the performance index values and the uniformity differences made between the original vs. the modified systems are shown in Figure 5. It can be seen that the index values were lower for center pivot systems with modified laterals as compared with the center pivot systems equipped with the original laterals. Also, Figure 5 shows the difference in values between C_u for original and modified laterals, the average values of C_u for original systems ranged between 71.81 and 89.46% with an average of 82.69%, whereas the average values of C_u for modified systems ranged between 61.35 and 84.33% with an overall average of 78.05%. Also, the values of D_u (Figure 5) ranged between 54.14 and 81.81% with an overall average of 73.24% for the original systems. The values

of D_u for the modified systems ranged between 31.45 and 77.07% with an overall average of 66.87%. This also, indicates that original center pivot systems performed more accurately and applied water more uniformly to the soil surface as compared with the modified systems.

Taking 80 and 67% as acceptable performance levels for C_u and D_u , respectively, (Merriam and Keller, 1978), C_u and D_u values for most of the modified systems were below acceptable levels. But for the majority of original center pivot systems, irrigation water was distributed more uniformly and most values of C_u and D_u well above the 80 and 67% levels. Thus, it can be said that the performance of the original systems was better than the performance of the modified systems, and water applied more uniformly. Poor distribution uniformity and wide variations in depths of water applied along the laterals are obvious in the modified systems. This would adversely affect crop growth and yield of field crops irrigated through these center pivot systems.
