Effect of Center Pivot System Lateral Configuration on Water Application Uniformity in an Arid Area

ABSTRACT

Keywords: Application uniformity, Center pivot, Lateral configuration, Sprinkler irrigation.

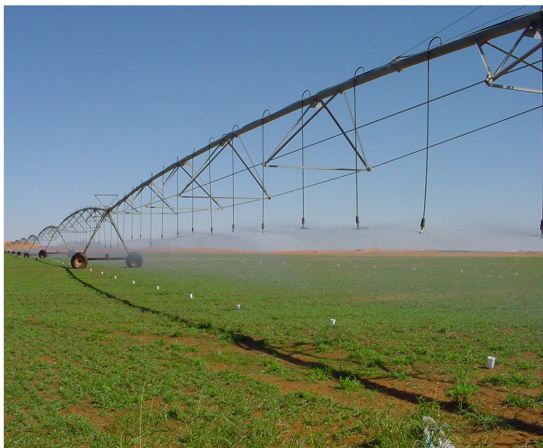
(a) Original lateral

The original pivot lateral (Figure 1-a) within these center pivot systems was built of galvanized steel pipe (Table 1), while the center pivot systems with modified laterals (Figure 1-b) carried a polyethylene pipe of the same diameter all through and positioned below the original lateral. The height of the modified lateral was close to the soil surface as compared with the original lateral with the new height from soil surface ranging between 1.5 and 2.0 m, and the lengths of the drop tubes connected to the modified lateral ranging from 0.5 to 1.0 m. none of the sprinklers, installed along the modified lateral were equipped with pressure regulators.

Figure 1. Two types of center pivot systems employed in the study with (a) original and (b) modified laterals.

were caused by an improper location of the laterals and their variations in height from the soil surface (Figure 1-b) and subsequent variations in the nozzles' pressure along the lateral. This caused the sprinkler discharge and application depth patterns along the modified laterals to be different from those in the laterals of original installments.

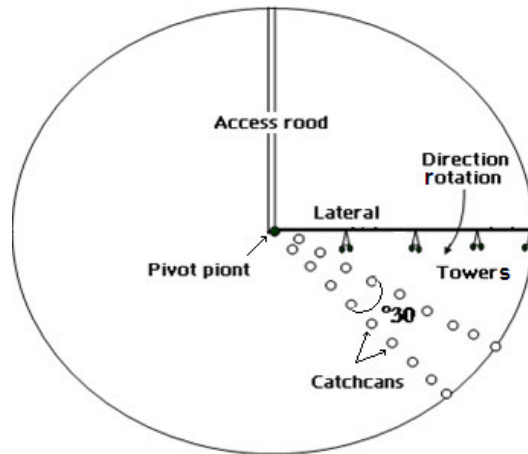
Figure 2. Field layout and schematic diagram demonstrating the distribution of catch cans.

the methodology of Merriam and Keller (1978) and ASABE Standard, S436.1 (2007). Wind speeds ranged from 1.5 to 6.3 m s^{-1} , the air temperature from 17 to 30°C, and while the relative humidity varying between 28 and 57 %. Two rows of catch cans were used in each system to measure the uniformity of water distribution in the radial direction as shown in Figure 2. The catch can spacing was chosen 5 m with the first can at 11.6 m from the pivot point (Merriam and Keller, 1978). Catch cans of 16 cm inside diameters and 15 cm heights were made use of. The catch cans were placed along a line extending radially from the pivot point. The two lines were sufficiently distanced apart from the pipeline to allow for the system to allow for the testing conditions. The operating speed of

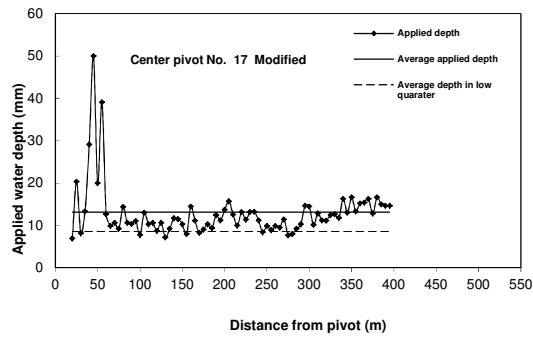
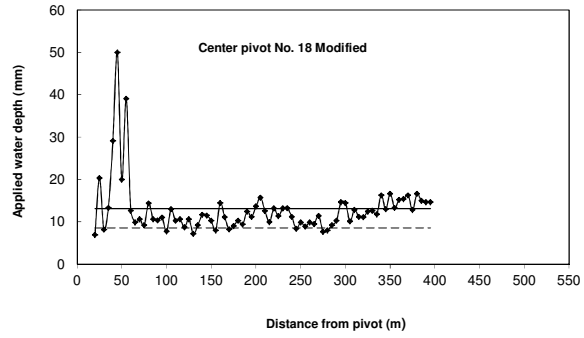
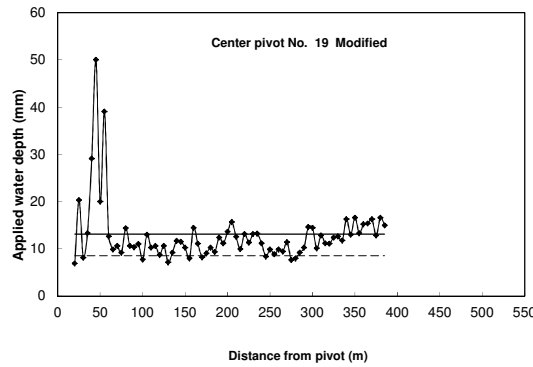
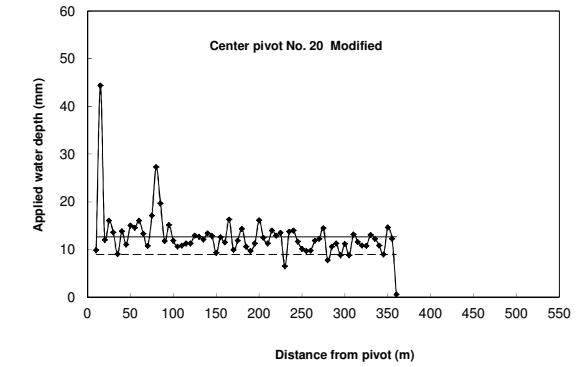
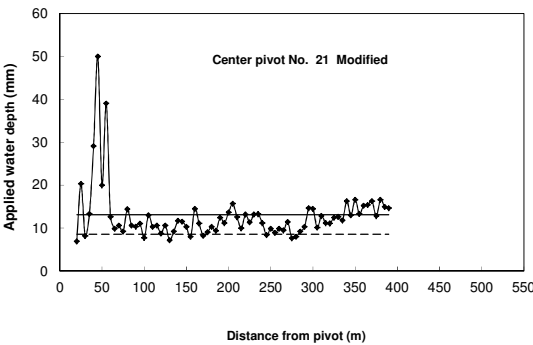
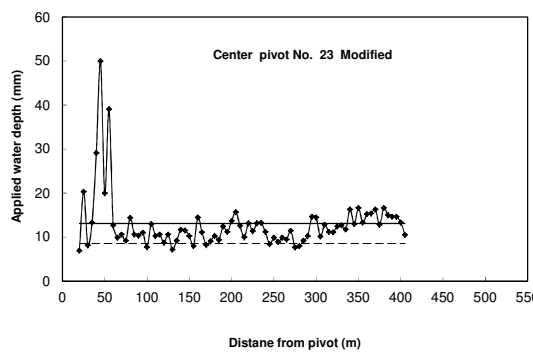
(a)

Water application uniformity is a measure of how evenly water is spread over the soil surface during irrigation under different field operating conditions. Water distribution profiles along the laterals of the tested center pivot systems are shown in Figures 3 (a and b) and 4 (a and b) for original and modified laterals, respectively. The profiles depict water depths caught in each can along the lateral for each of the 32 center pivot

systems. The figures show that substantial areas of the center pivot systems were receiving less than the average amount of water applied and there was substantial variation in depth of water applied along the lateral from one system to another, especially for center pivot systems with modified laterals. Average depths and average low quarter depths of application for each system were determined and displayed (Figures 3 and 4). Average depths and the low quarter average depths of application for 24 center pivot systems equipped with original laterals ranged from 24.33 to 4.31 mm, and from 17.42 to 2.33 mm respectively, whereas, the average depths and the low quarter average depths of application for the 24 modified systems (Figure 4) ranged from 13.23 to 5.23 mm and from 9.36 to 3.59 mm respectively. It can be seen that both depth values for the original systems were higher than those for modified systems. This indicates that more water was applied through the original center pivot systems to the irrigated areas as compared with the center pivot systems with modified laterals and when at the same travel speed. The lower depth values were attributed to lateral configurations changes made by farmers, bringing about pressure variations, improper nozzling, inaccurate water patterns and as well leakage along the laterals.

Figure 3. Water distribution patterns in radial direction with the average depths and the average low quarter depths of application recorded from center pivot systems with original laterals.

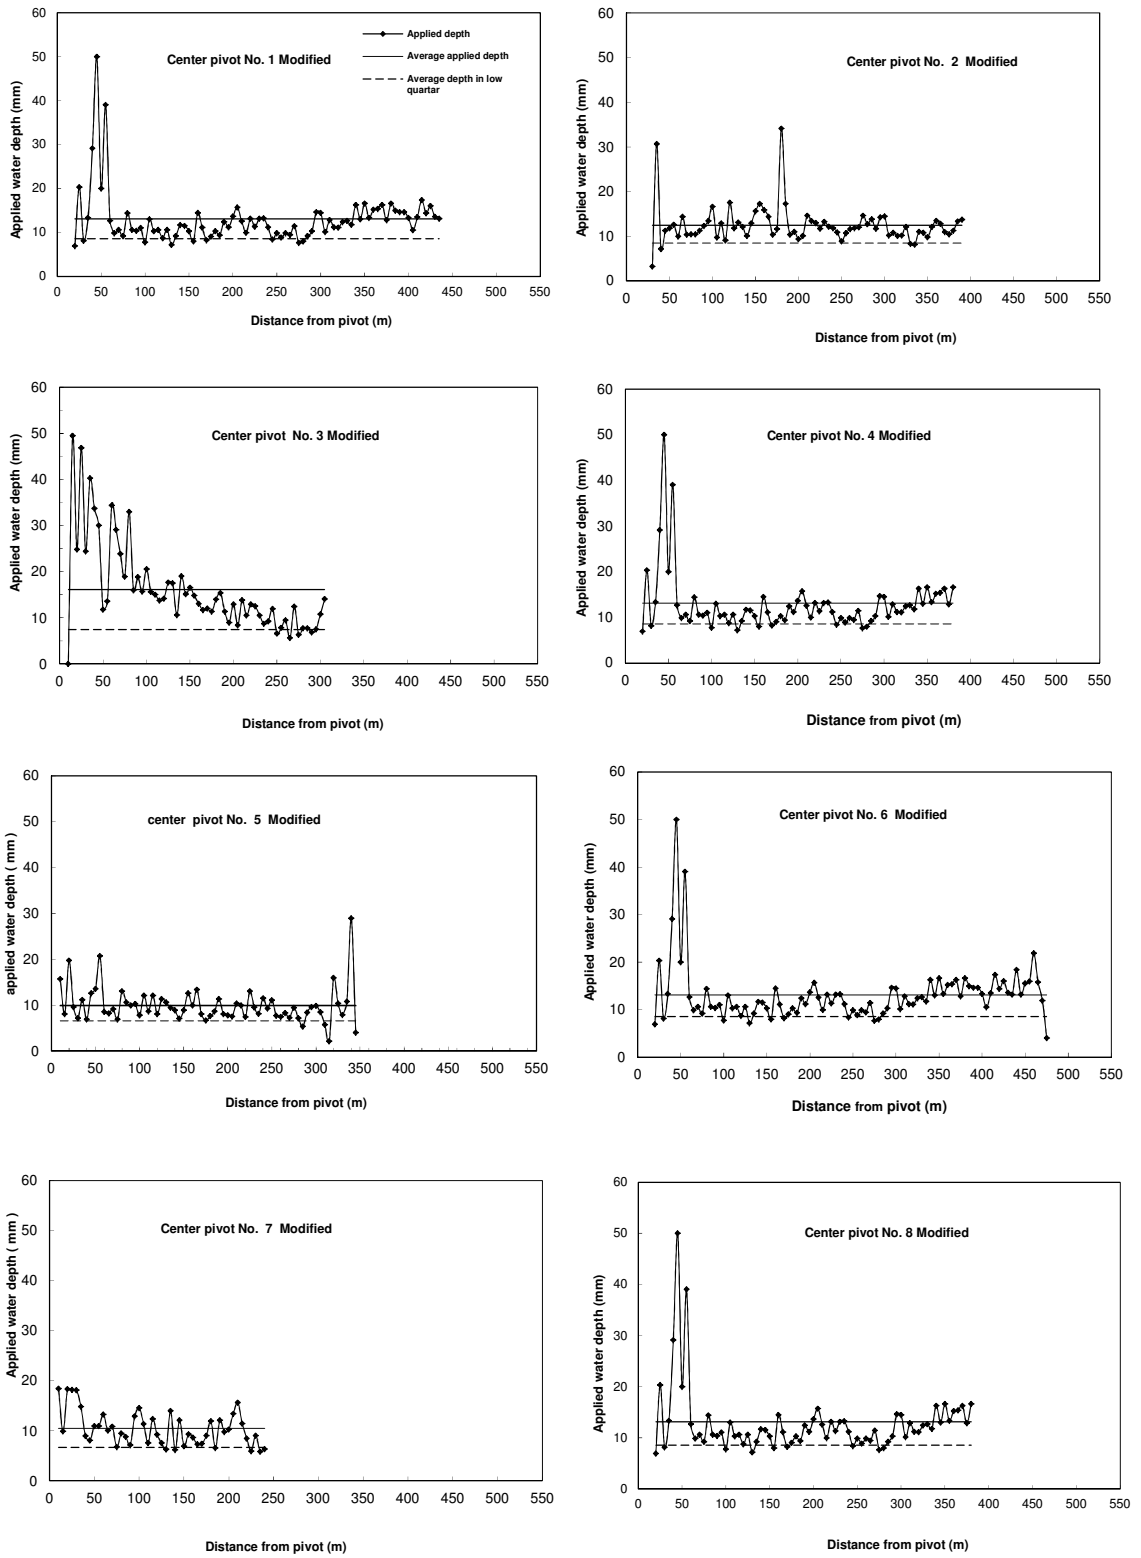
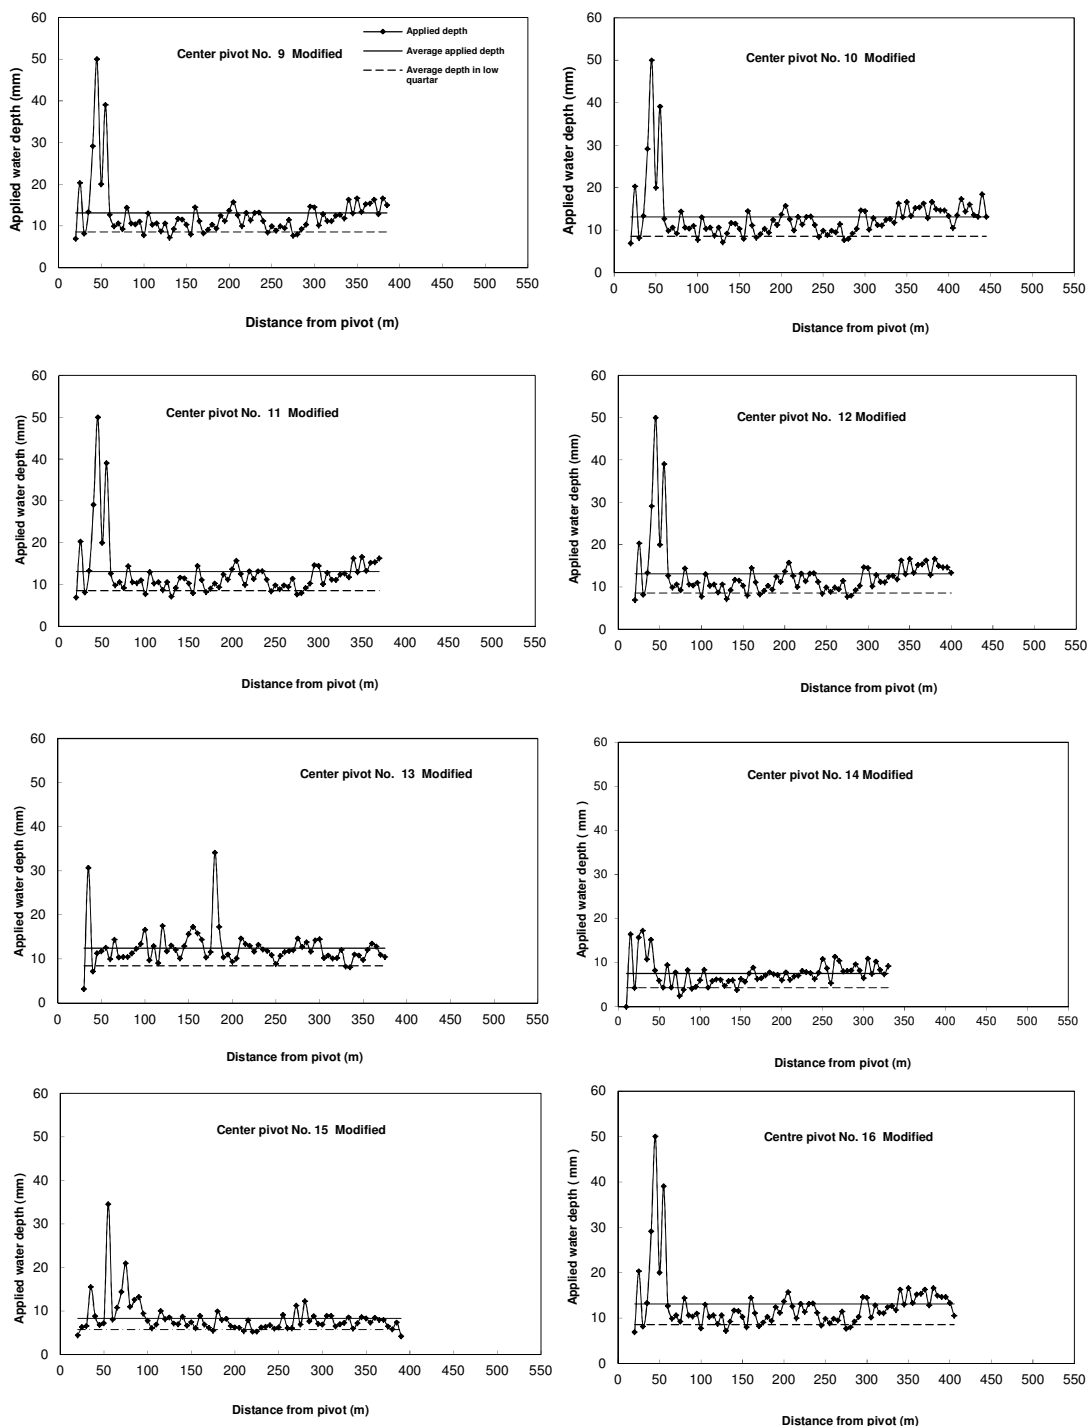
(a)

Figure 4. Water distribution patterns in radial direction with the average depths and the average low quarter depths of application recorded from center pivot systems with modified laterals.
