Structural stability analysis of naturally ventilated polyhouses under different conditions

ABSTRACT

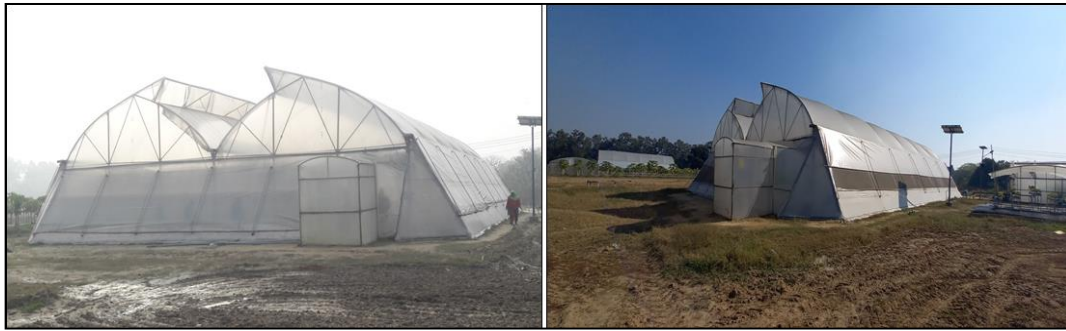
Figure 1. Front view of 560 m² polyhouse at PAU, Ludhiana.

There were 12 treatments taken for the research study and were combination of four different sizes of polyhouses i.e. 560 m², 1,008 m², 2,080 m² and 4,000 m² with three design wind speeds of 100, 150, and 200 km h⁻¹ as shown in Table 1. Their detail drawings were drawn and their dimensions and materials were studied in details with their technical specifications. Figure 1 shows the photograph of different views of 560 m² sizes of naturally ventilated polyhouse located in Punjab Agricultural University, Ludhiana Punjab.

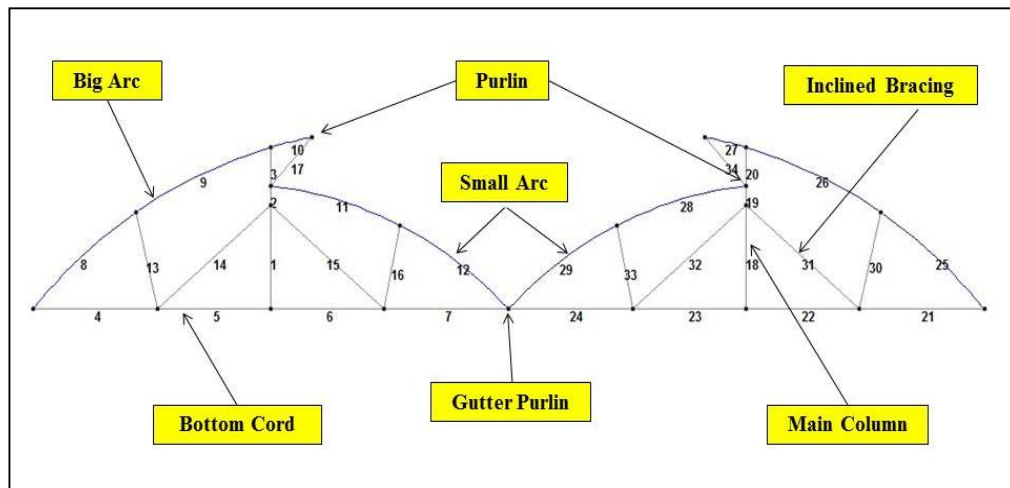
Figure 2. Details of truss members of polyhouse structure.

The procedure for structural stability analysis consists of checking the stability of trusses including its each member, main and side columns and foundations for each of the twelve treatments (T1–T12) as shown in Table 2. The truss member includes main column, bottom chord, big arc, small arc, and truss bracings as shown in Figure 2. The specification of structural components of different sizes of polyhouse and truss members are shown in Tables 2 and 3, respectively, which were taken from Indian Standard (IS:14462 1997) and technical recommendations (Anonymous, 2019).

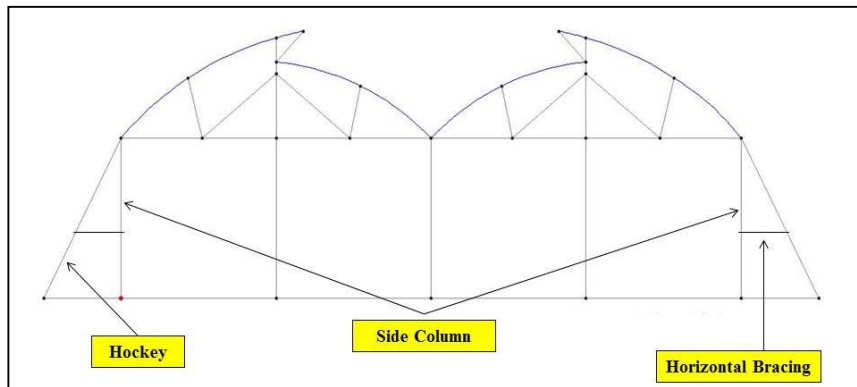
Figure 3. Lower portion members of polyhouse structure.

The lower portion of polyhouse structure consist of five major components (Figure 3) i.e. main column, side column, horizontal bracing, hockey, curtain runner and side column to column inclined bracing and initial dimensions of these components are shown in Table 3.

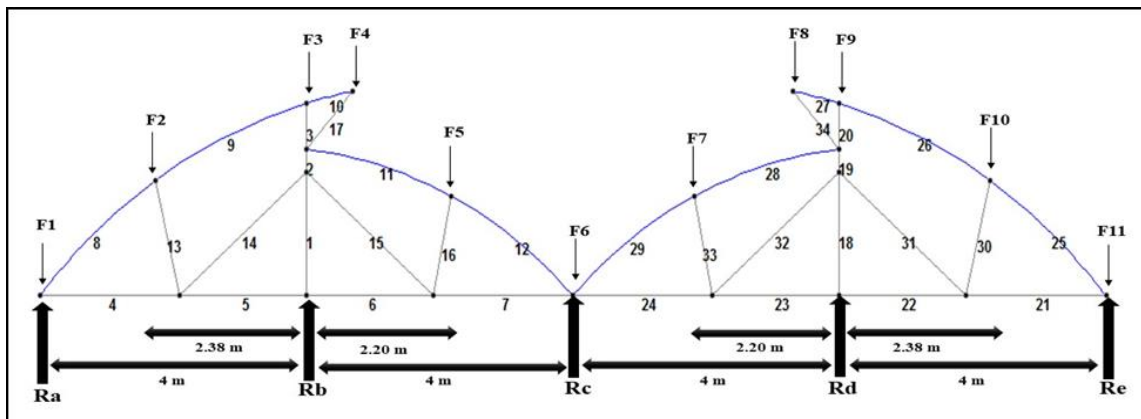
Figure 4. Support reactions on trusses.

The support reactions shown in Figure 4 were determined for all the treatments. Figure 4 shows the support reactions on 560 m² polyhouse. Computation of member forces was carried out using force method. Positive sign of member force due to loads indicates that the force acts towards the

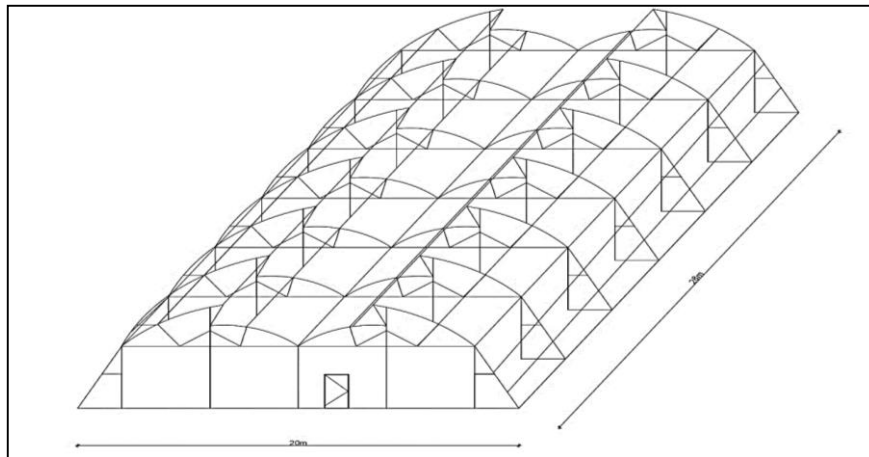
**Figure 5.** Isometric view of 560 m² polyhouse structure (T1/T2/T3).

The truss member forces were calculated by the following force method. Treatment T1/T2/T3 contains 34 truss members (Figure 5), out of which 17 member forces are shown in Tables 4-6 with their stable diameters and their designed force value that are more than the maximum force value, a condition for their structural stability, while the rest of 17 members forces repeat themselves. Treatment T4/T5/T6 contains 68 truss members (Figure 6), out of which 17 member forces are shown in Tables 7-9 with their stable diameters and their designed force value that are more than the maximum force value, a condition for their structural stability, while the rest of 51 members forces repeat themselves after every 17 members. Treatment T7/T8/T9 contains 102 truss

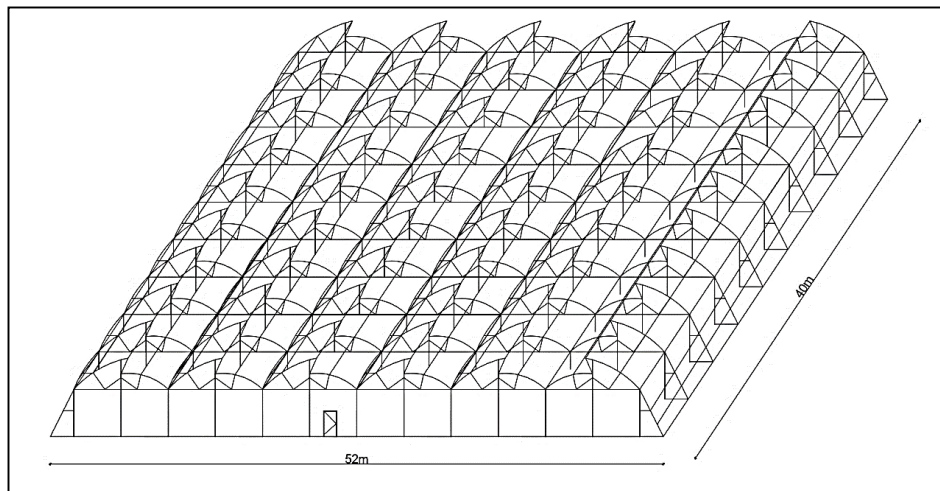
**Figure 7.** Isometric view of 2080 m² polyhouse structure (T7/T8/T9).

members (Figure 7), out of which 17 member forces are shown in Tables 10-12 with their stable diameters and their designed force value that are more than the maximum force value, a condition for their structural stability, while the rest of 85 members forces repeat themselves after every 17 members. Treatment T10/T11/T12 contains 204 truss members (Figure 8), out of which 17 member forces are shown in Tables 13-15 with their stable diameters and their designed force value that are more than the maximum force value, a condition for their structural stability, while the rest of 187 members forces repeat themselves after every 17 members. Initial specifications (diameter) for different truss members, as recommended by Indian standards, were reduced in size for each truss member and complete structural analysis was carried out.
