## Erosion Risk Mapping Using CORINE Methodology for Goz Watershed in Kahramanmaras Region, Turkey

Soil erosion may cause serious environmental impacts on soil and water resources such as excessive sedimentation, especially on steep terrain and erodible soils in arid and semi-arid areas. The sediment yield due to erosion has also economic consequences on dam watersheds by affecting economic life of dams, which are one of the most important infrastructure investments in Turkey. Thus, it is very important to determine potential erosion risk in order to develop adequate erosion prevention measures in dam watersheds. This study aimed to develop erosion risk map for Goz Watershed of Menzelet Dam in the eastern Mediterranean city of Kahramanmaras in Turkey. In the methodology, Remote Sensing (RS) and Geographic Information System (GIS) technologies were employed based on COOrdination of INformation on the Environment (CORINE) methodology. The results indicated that 54.52% of the Goz Watershed was under moderate erosion risk, while there was a high erosion risk in 45.48% of the watershed based on the potential erosion risk map. According to actual erosion risk maps, 11.97 and 88.03% of t

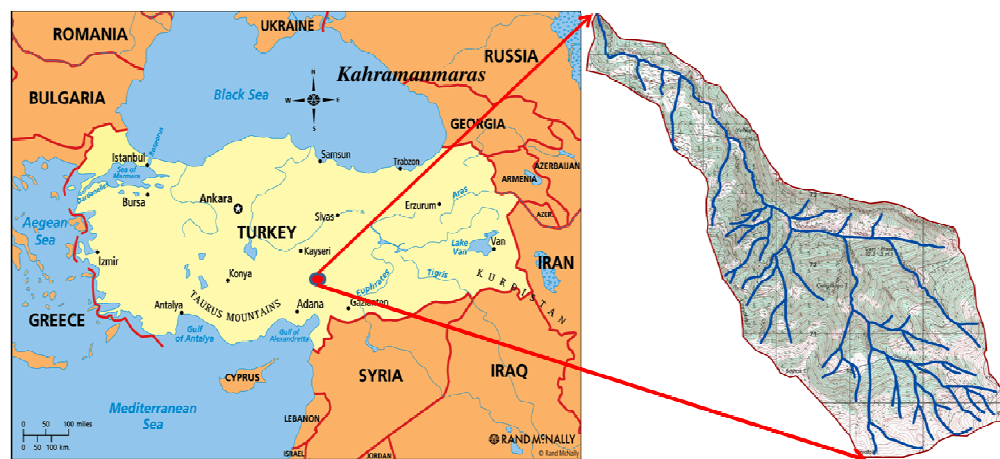
**Figure 1.** Goz Watershed of Menzelet Dam in Kahramanmaraş.

Goz Watershed, a sub-watershed of Menzelet Dam was selected as the study area. The watershed is 45 km away from the city of Kahramanmaras and has an area of 1,336.6 ha (Figure 1). It is located between the latitudes of 37° 39' 58" and 36° 40' 54" North, and the longitudes of 36° 54' 28" and 36° 57' 59" East. The average elevation and ground slope was 1,295 m and 38%, respectively.

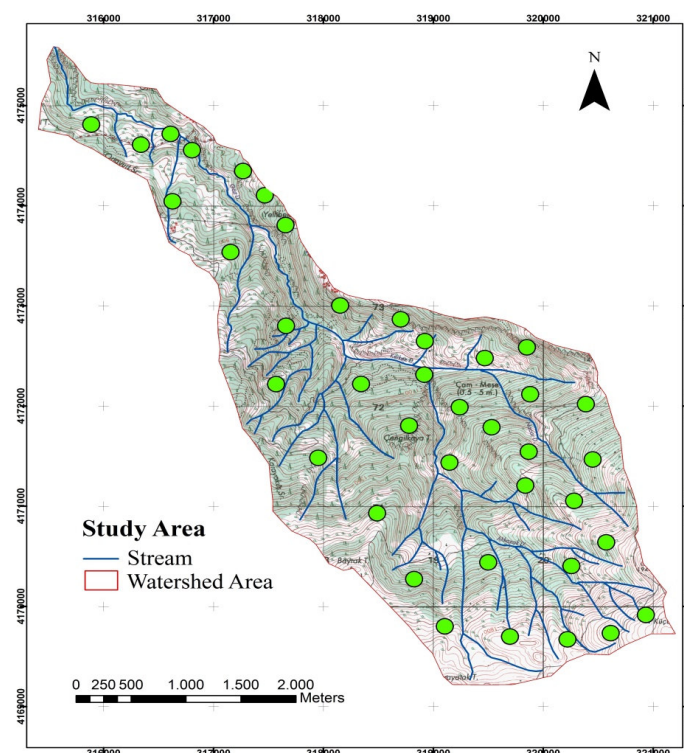
Figure 2. Soil sampling points in the study area.

Figure 2 indicates the soil sampling points in the study area. Then, only those soils that passed through a 2 mm sieve were evaluated in laboratory. Soil texture class map was interpolated with “Thiessen Polygon” for the whole watershed. Soil texture classification was made according to USDA texture classification (SSM, 1993).

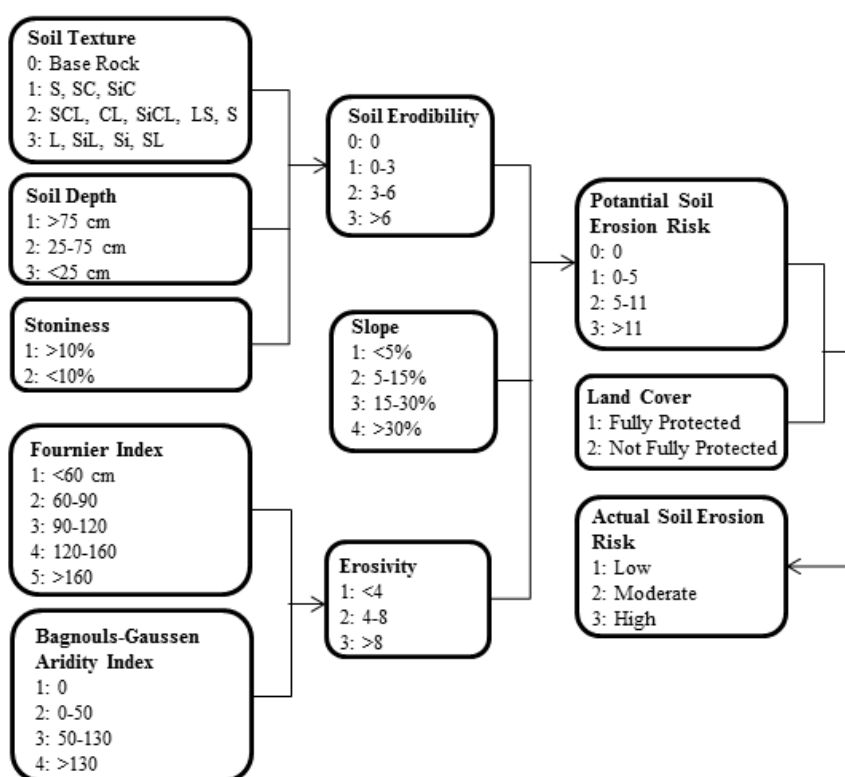
Figure 3. Flow diagram of the CORINE methodology (C: Clay; S: Sandy; Si: Silt, L: Loam).

In the CORINE methodology, soil texture was grouped into three classes including: Slightly erodible (1), Moderately erodible (2), and Highly erodible (3) (Figure 3). Soil maps were used in order to classify soil stoniness and soil depth, which are important indicators of erosion. The stoniness was classified as: Fully protected (1), and Not fully protected (2) soils, by considering the percentage surface cover of stones. The soil depth, which is the depth from the soil surface to the base of the soil profile, was classified as slightly erodible (>75 cm) (1), moderately erodible (25-75 cm) (2), and highly erodible (<25 cm) (3) soils. Finally, the soil erodibility index was calculated by multiplying these three soil factors (CORINE, 1992; Bayramin *et al.*, 2003; Aydın and Tecimen, 2010) and reclassified

Where,  $T_i$  is the mean temperature for the month,  $P_i$  is the total precipitation for month, and  $k_i$  is the proportion of the month during which  $2T_i - P_i > 0$ . The *BGI* was classified into: Humid (1), Moist (2), Dry (3), and Very dry (4). Finally, erosivity index was determined by multiplying Fournier and Bagnouls-Gausson aridity indices. The input data of precipitation and temperature were obtained from the nearest weather station in Kahramanmaraş for the period of 1985-2010. Finally, erosivity index was reclassified into: Low (1), Moderate (2), and High (3) (Figure 3).

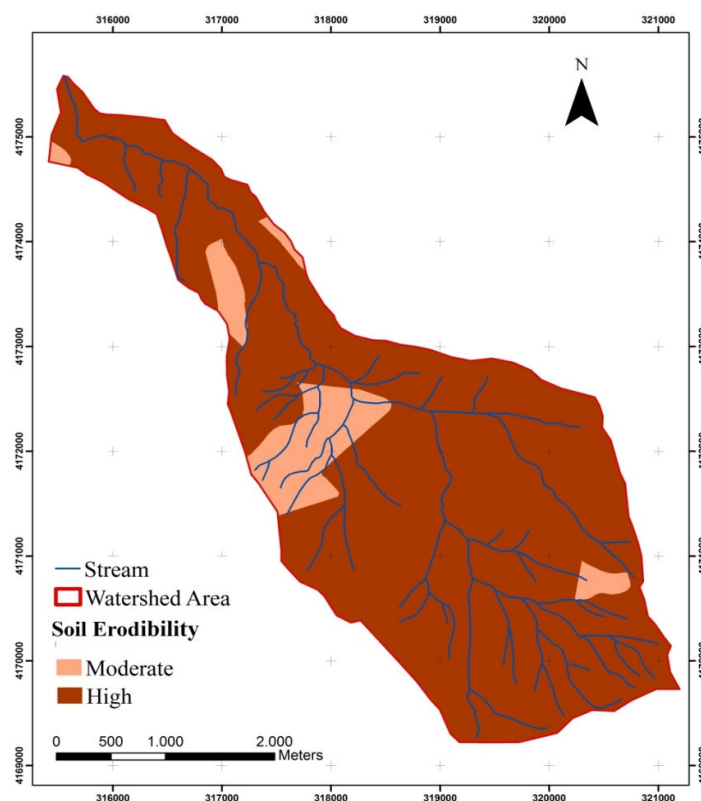
Figure 4. The soil erodibility map of the study area.

Based on soil texture, stoniness, and depth parameters, erodibility factor was moderate (3-6) in 9.5% (126.81 ha) of the total area while it was classified as high (> 6) in 90.5% (1207.98 ha) of the area. Thus, the soil in most parts of the study area was subject to erosion risk considering soil erodibility factor (Figure 4).

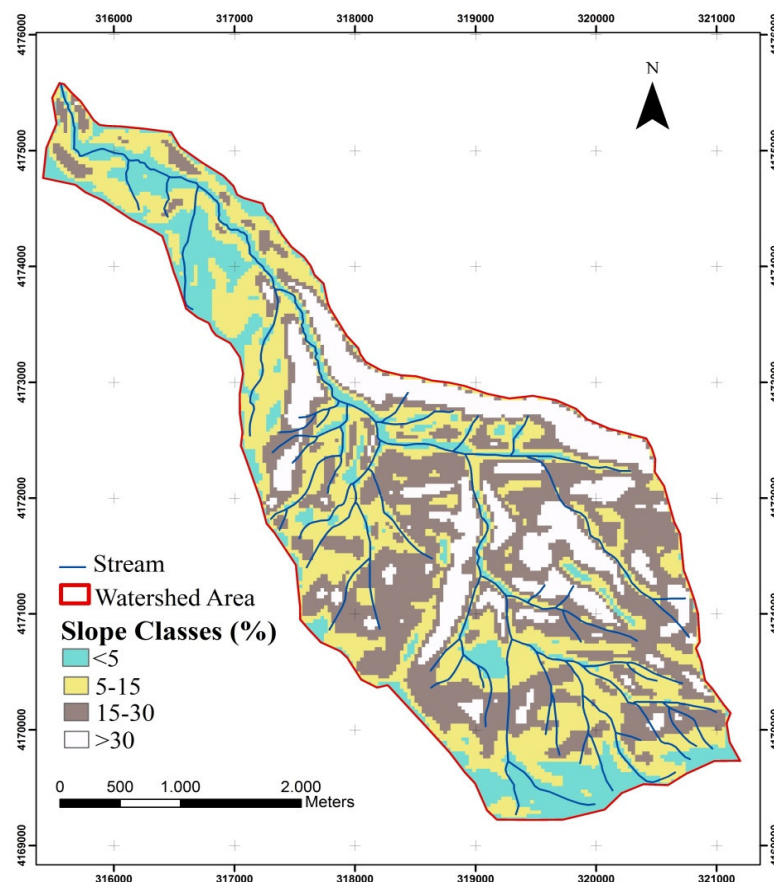
Figure 5. The slope classes map of the study area.

The topographic factors, especially ground slope, are important in terms of estimating erosion. The steep ground slope potentially accelerates the surface runoff, which dramatically increases erosion (Lal, 1994). The results indicated that the average slope in Goz Watershed was 38%. It was estimated that about 50.42% of the watershed was classified as steep and very steep areas, while the rest was on gentle slope (29.52%) and flat (20.06%) (Figure 5).

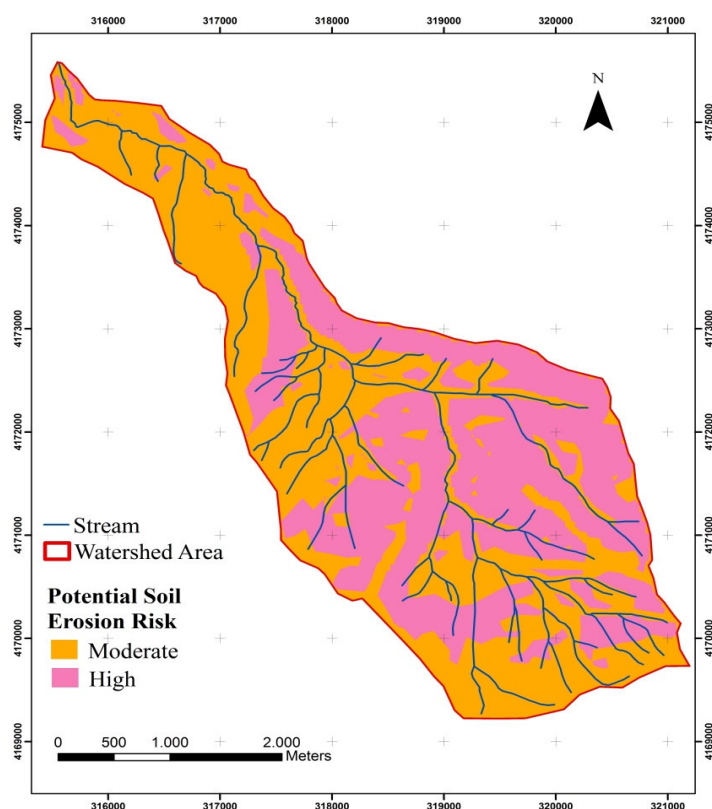
Figure 6. The potential erosion risk map of the study area.

The potential soil erosion risk of the study area was determined and then mapped (Figure 6). The potential erosion risk map indicated that the study area had 54.52% moderate and 45.48% high erosion risk levels. The actual erosion risk map was generated by overlaying potential erosion risk map and land cover map (Figure 7). Reliability of land cover data is very important in soil erosion models (Odoro-Afriye, 1996). The accuracy assessment of

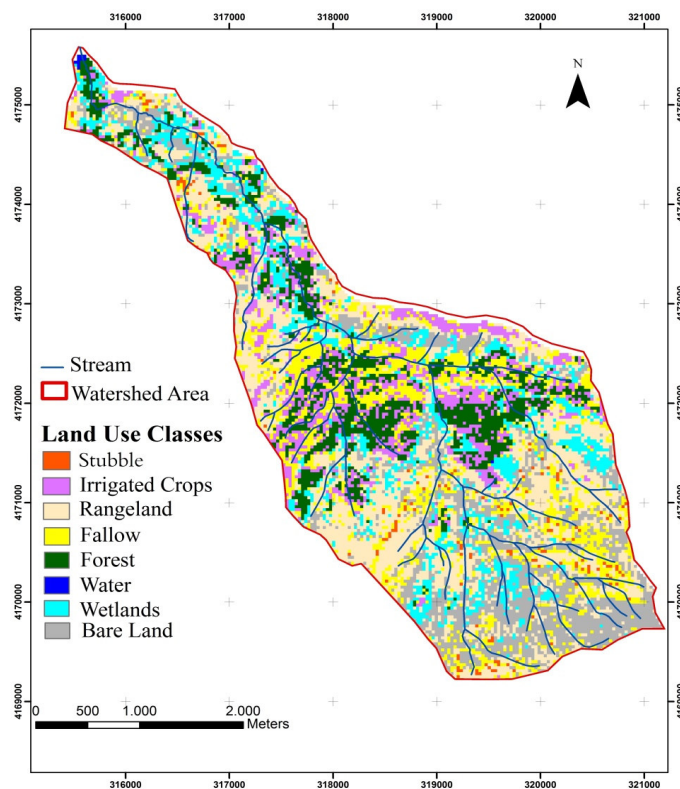
Figure 7. Land use map of the study area.

In the study area, forest was classified as fully protected (1), while the rest i.e. irrigated crops, stubble, fallow, wetlands, rangeland, and bare land were classified as not-fully protected (2). Land cover map indicated that the study area was 88.33% not-fully and 11.67 % was fully protected. Actual erosion risk map indicated that 11.97% of the study area had moderate risk, while 88.03% of the study area possesses high erosion risk (Figure 8).

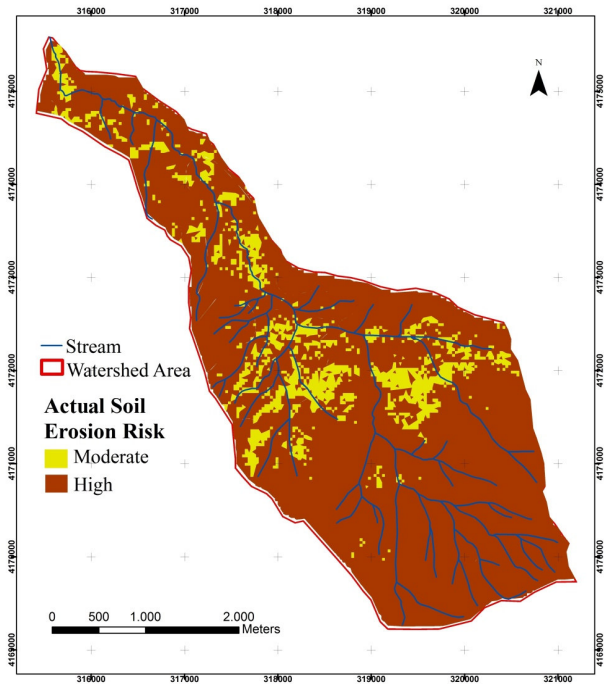
Figure 8. The actual erosion risk map of the study area.
