Structural stability analysis of naturally ventilated polyhouses under different conditions

ABSTRACT

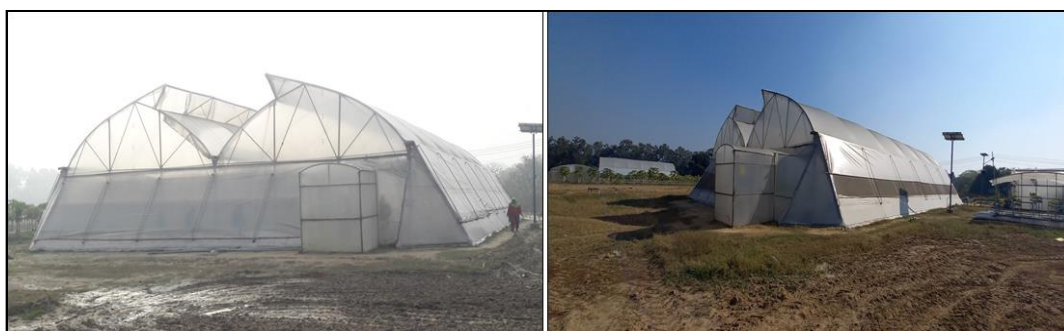
Figure 1. Front view of 560 m² polyhouse at PAU, Ludhiana.

There were 12 treatments taken for the research study and were combination of four different sizes of polyhouses i.e. 560 m², 1,008 m², 2,080 m² and 4,000 m² with three design wind speeds of 100, 150, and 200 km h⁻¹ as shown in Table 1. Their detail drawings were drawn and their dimensions and materials were studied in details with their technical specifications. Figure 1 shows the photograph of different views of 560 m² sizes of naturally ventilated polyhouse located in Punjab Agricultural University, Ludhiana Punjab.

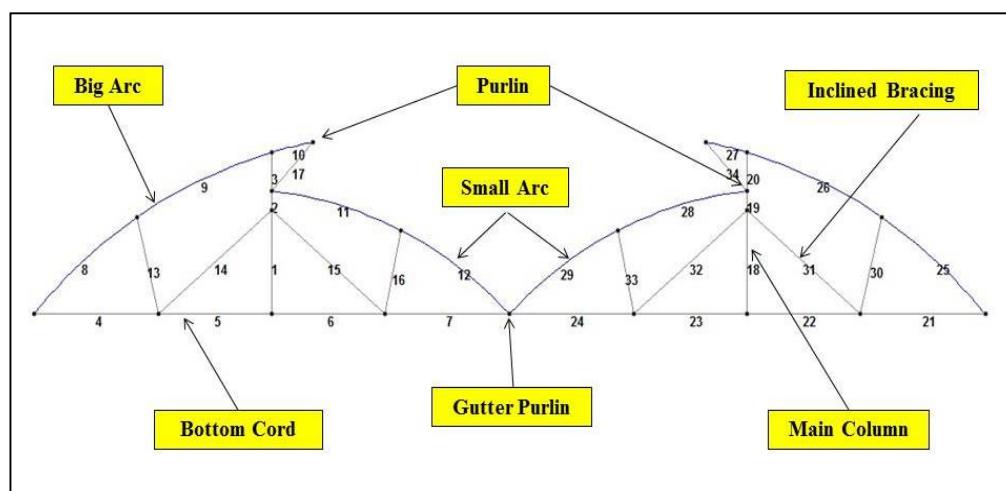
Figure 2. Details of truss members of polyhouse structure.

The procedure for structural stability analysis consists of checking the stability of trusses including its each member, main and side columns and foundations for each of the twelve treatments (T1–T12) as shown in Table 2. The truss member includes main column, bottom chord, big arc, small arc, and truss bracings as shown in Figure 2. The specification of structural components of different sizes of polyhouse and truss members are shown in Tables 2 and 3, respectively, which were taken from Indian Standard (IS:14462 1997) and technical recommendations (Anonymous, 2019).

S no	Truss members	Sub-truss members	Length (m)	Diameter (mm)	Thickness (mm)
1	Main column	1	1.60	76	2
		2	0.30	76	2
		3	0.60	76	2
2	Bottom chord	4	2.10	60	2
		5	1.90	60	2
		6	1.90	60	2
		7	2.10	60	2
3	Big arc	8	2.29	48	2
		9	2.48	48	2
		10	0.72	48	2
4	Small arc	11	2.25	48	2
		12	2.25	48	2
5	Truss bracings	13	1.54	32	2
		14	2.48	32	2
		15	2.48	32	2
		16	1.33	32	2
		17	1.03	32	2
6	Purlins	18	4.0	48	2

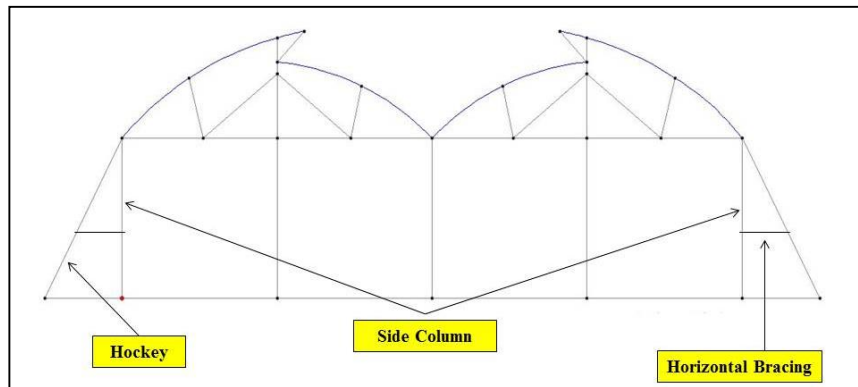
Figure 3. Lower portion members of polyhouse structure.

The lower portion of polyhouse structure consist of five major components (Figure 3) i.e. main column, side column, horizontal bracing, hockey, curtain runner and side column to column inclined bracing and initial dimensions of these components are shown in Table 3.

S no	Items	Diameter (mm)	Thickness (mm)
1	Main column	76	2
2	Side column	76	2
3	Horizontal bracings	42	2
4	Hockey	60	3
5	Curtain runner	33	2
6	C/C inclined bracing	42	2

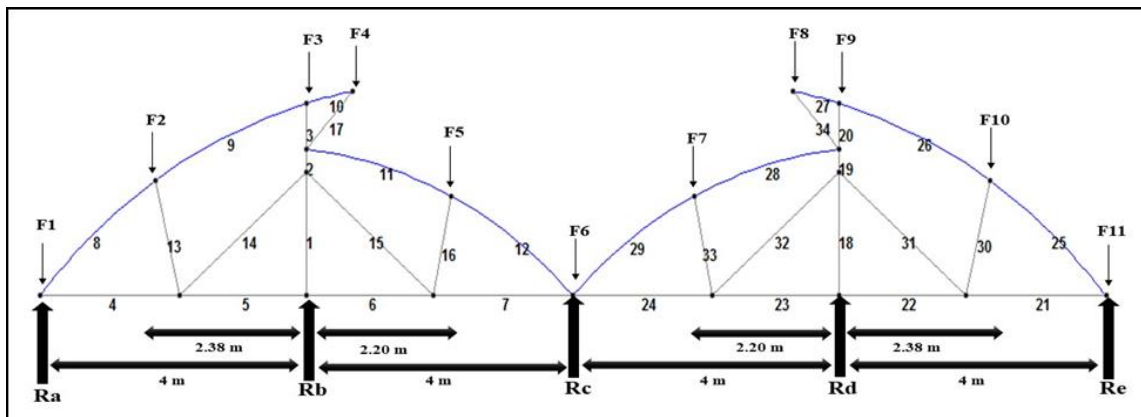
Figure 4. Support reactions on trusses.

The support reactions shown in Figure 4 were determined for all the treatments. Figure 4 shows the support reactions on 560 m² polyhouse. Computation of member forces was carried out using force method. Positive sign of member force due to loads indicates that the force acts towards the

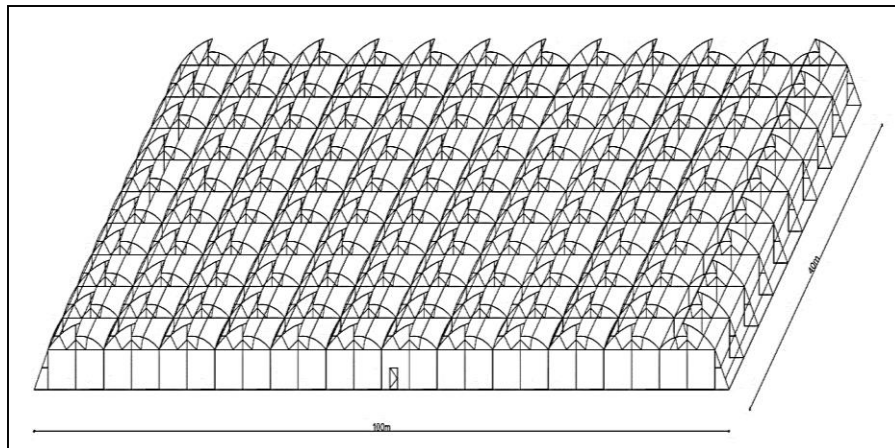
**Figure 8.** Isometric view of 4000 m² polyhouse structure (T10/T11/T12).
