Structural stability analysis of naturally ventilated polyhouses under different conditions

ABSTRACT

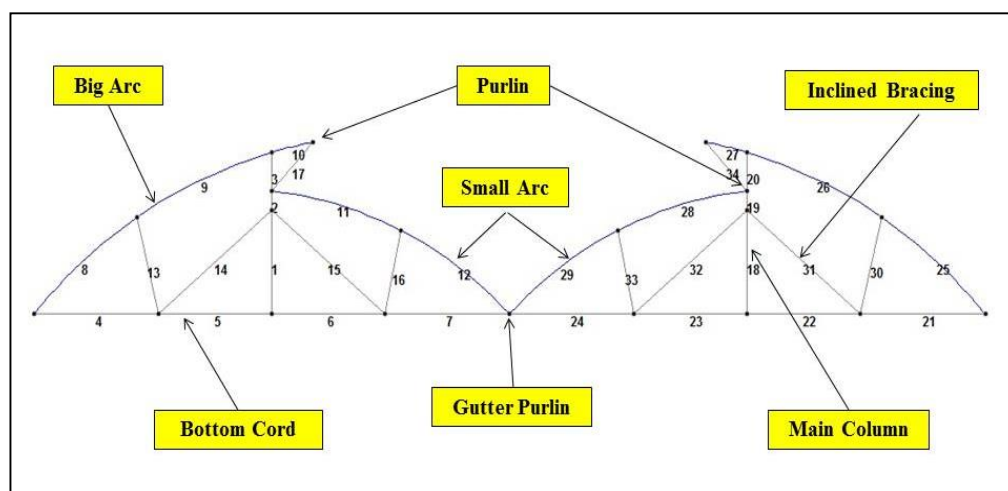
Figure 2. Details of truss members of polyhouse structure.

The procedure for structural stability analysis consists of checking the stability of trusses including its each member, main and side columns and foundations for each of the twelve treatments (T1–T12) as shown in Table 2. The truss member includes main column, bottom chord, big arc, small arc, and truss bracings as shown in Figure 2. The specification of structural components of different sizes of polyhouse and truss members are shown in Tables 2 and 3, respectively, which were taken from Indian Standard (IS:14462 1997) and technical recommendations (Anonymous, 2019).
