## **Effect of Center Pivot System Lateral Configuration on Water Application Uniformity in an Arid Area**

H. M. Al-Ghobari<sup>1</sup>

**Keywords:** Application uniformity, Center pivot, Lateral configuration, Sprinkler irrigation.

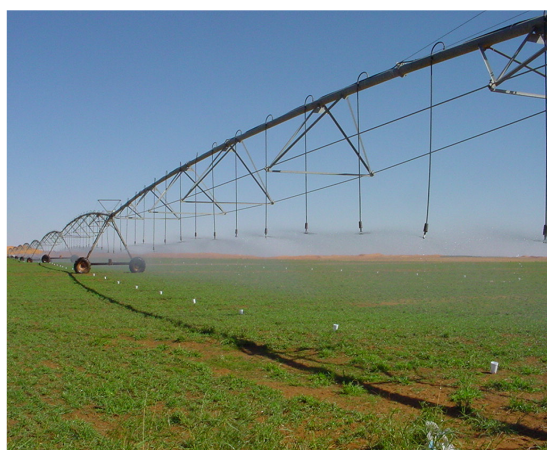
(a) Original lateral

The original pivot lateral (Figure 1-a) within these center pivot systems was built of galvanized steel pipe (Table 1), while the center pivot systems with modified laterals (Figure 1-b) carried a polyethylene pipe of the same diameter all through and positioned below the original lateral. The height of the modified lateral was close to the soil surface as compared with the original lateral with the new height from soil surface ranging between 1.5 and 2.0 m, and the lengths of the drop tubes connected to the modified lateral ranging from 0.5 to 1.0 m. none of the sprinklers, installed along the modified lateral were equipped with pressure regulators.

**Figure 1.** Two types of center pivot systems employed in the study with (a) original and (b) modified laterals.

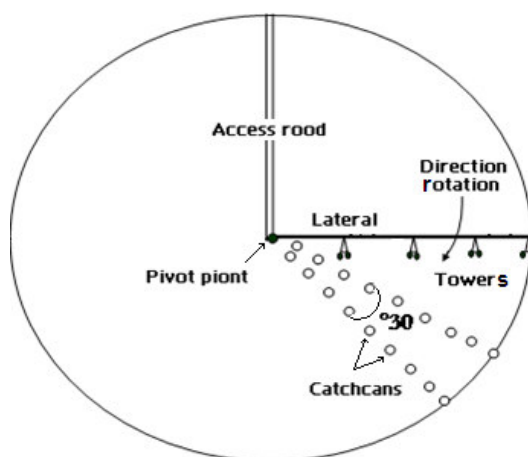
**Figure 2.** Field layout and schematic diagram demonstrating the distribution of catch cans.

the methodology of Merriam and Keller (1978) and ASABE Standard, S436.1 (2007). Wind speeds ranged from 1.5 to 6.3  $\text{m s}^{-1}$ , the air temperature from 17 to 30°C, and while the relative humidity varying between 28 and 57 %. Two rows of catch cans were used in each system to measure the uniformity of water distribution in the radial direction as shown in Figure 2. The catch can spacing was chosen 5 m with the first can at 11.6 m from the pivot point (Merriam and Keller, 1978). Catch cans of 16 cm inside diameters and 15 cm heights were made use of. The catch cans were placed along a line extending radially from the pivot point. The two lines were sufficiently distanced apart from the pipeline to allow for the system to allow for the testing conditions. The operating speed of

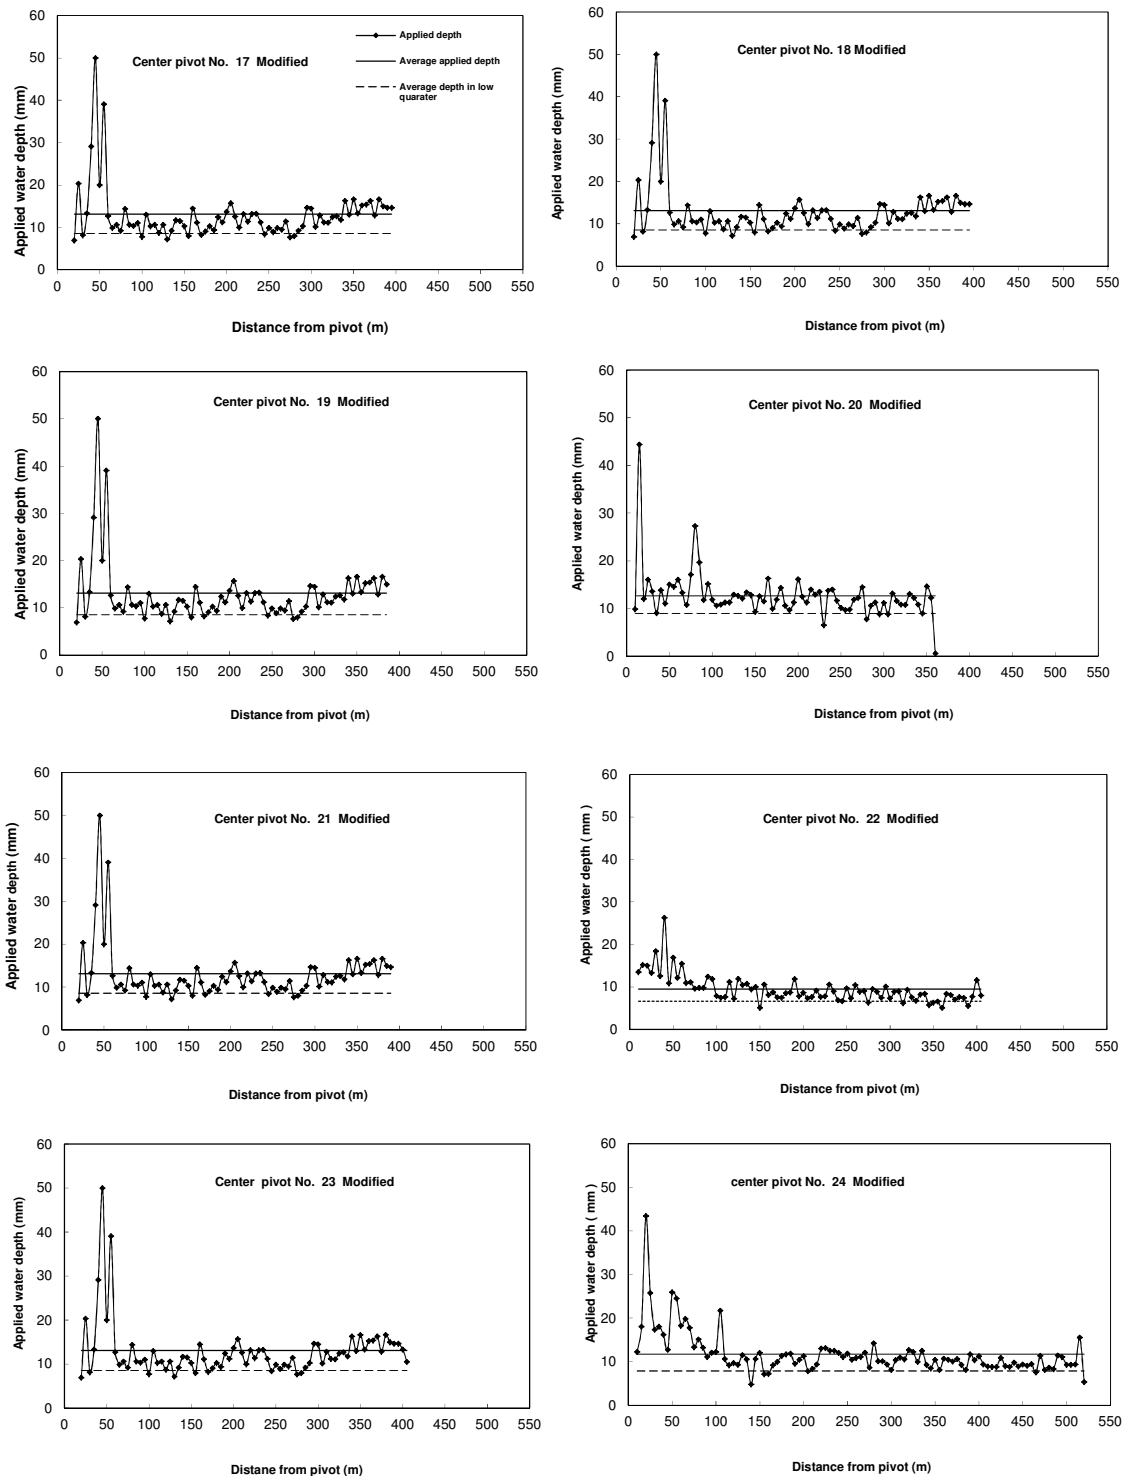
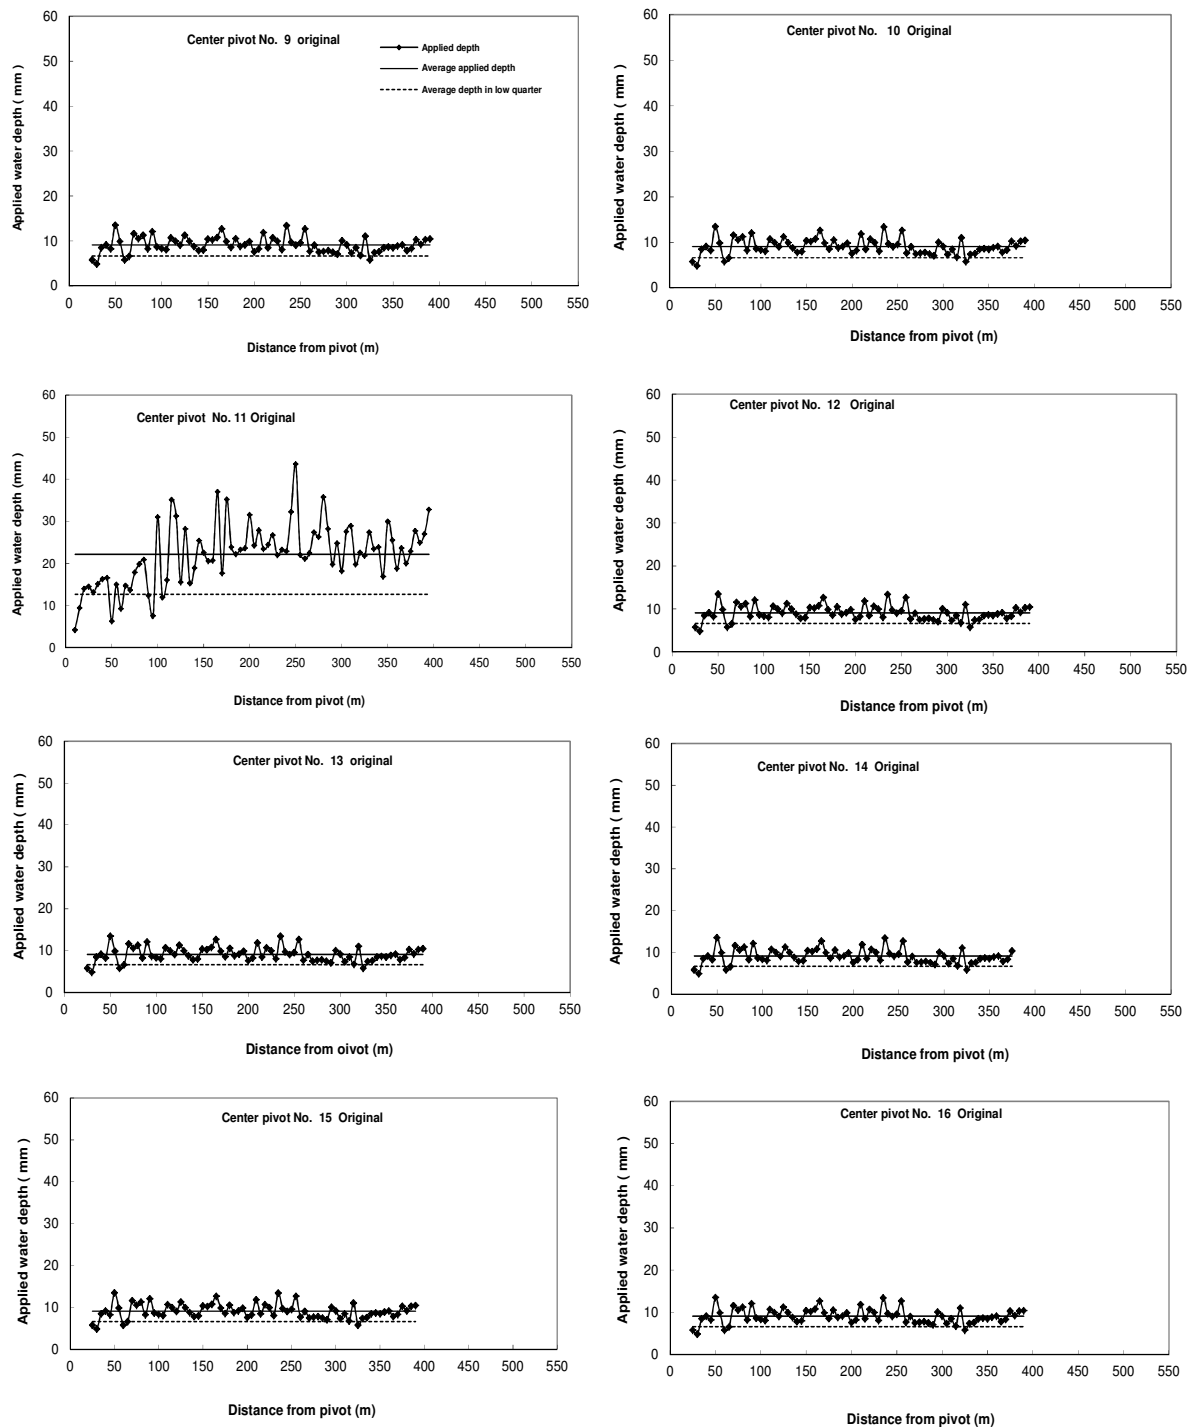
**Figure 3.** Water distribution patterns in radial direction with the average depths and the average low quarter depths of application recorded from center pivot systems with original laterals.

Water application uniformity is a measure of how evenly water is spread over the soil surface during irrigation under different field operating conditions. Water distribution profiles along the laterals of the tested center pivot systems are shown in Figures 3 (a and b) and 4 (a and b) for original and modified laterals, respectively. The profiles depict water depths caught in each can along the lateral for each of the 32 center pivot

systems. The figures show that substantial areas of the center pivot systems were receiving less than the average amount of water applied and there was substantial variation in depth of water applied along the lateral from one system to another, especially for center pivot systems with modified laterals. Average depths and average low quarter depths of application for each system were determined and displayed (Figures 3 and 4). Average depths and the low quarter average depths of application for 24 center pivot systems equipped with original laterals ranged from 24.33 to 4.31 mm, and from 17.42 to 2.33 mm respectively, whereas, the average depths and the low quarter average depths of application for the 24 modified systems (Figure 4) ranged from 13.23 to 5.23 mm and from 9.36 to 3.59 mm respectively. It can be seen that both depth values for the original systems were higher than those for modified systems. This indicates that more water was applied through the original center pivot systems to the irrigated areas as compared with the center pivot systems with modified laterals and when at the same travel speed. The lower depth values were attributed to lateral configurations changes made by farmers, bringing about pressure variations, improper nozzling, inaccurate water patterns and as well leakage along the laterals.

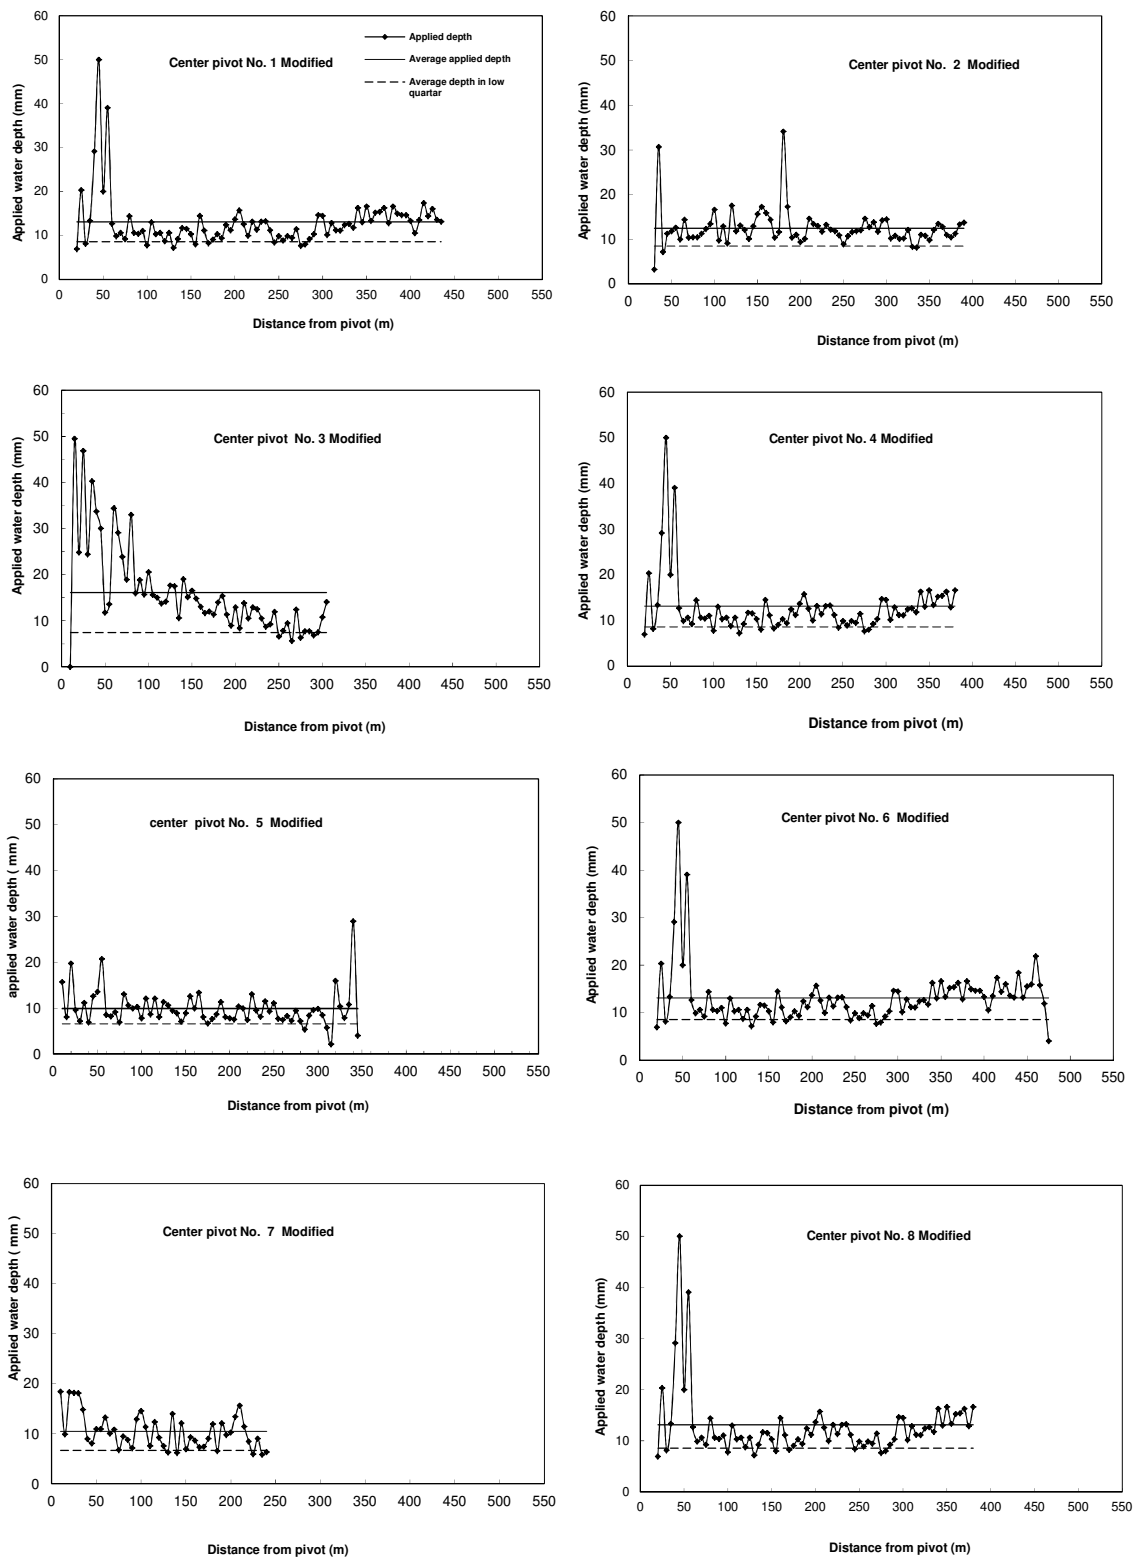
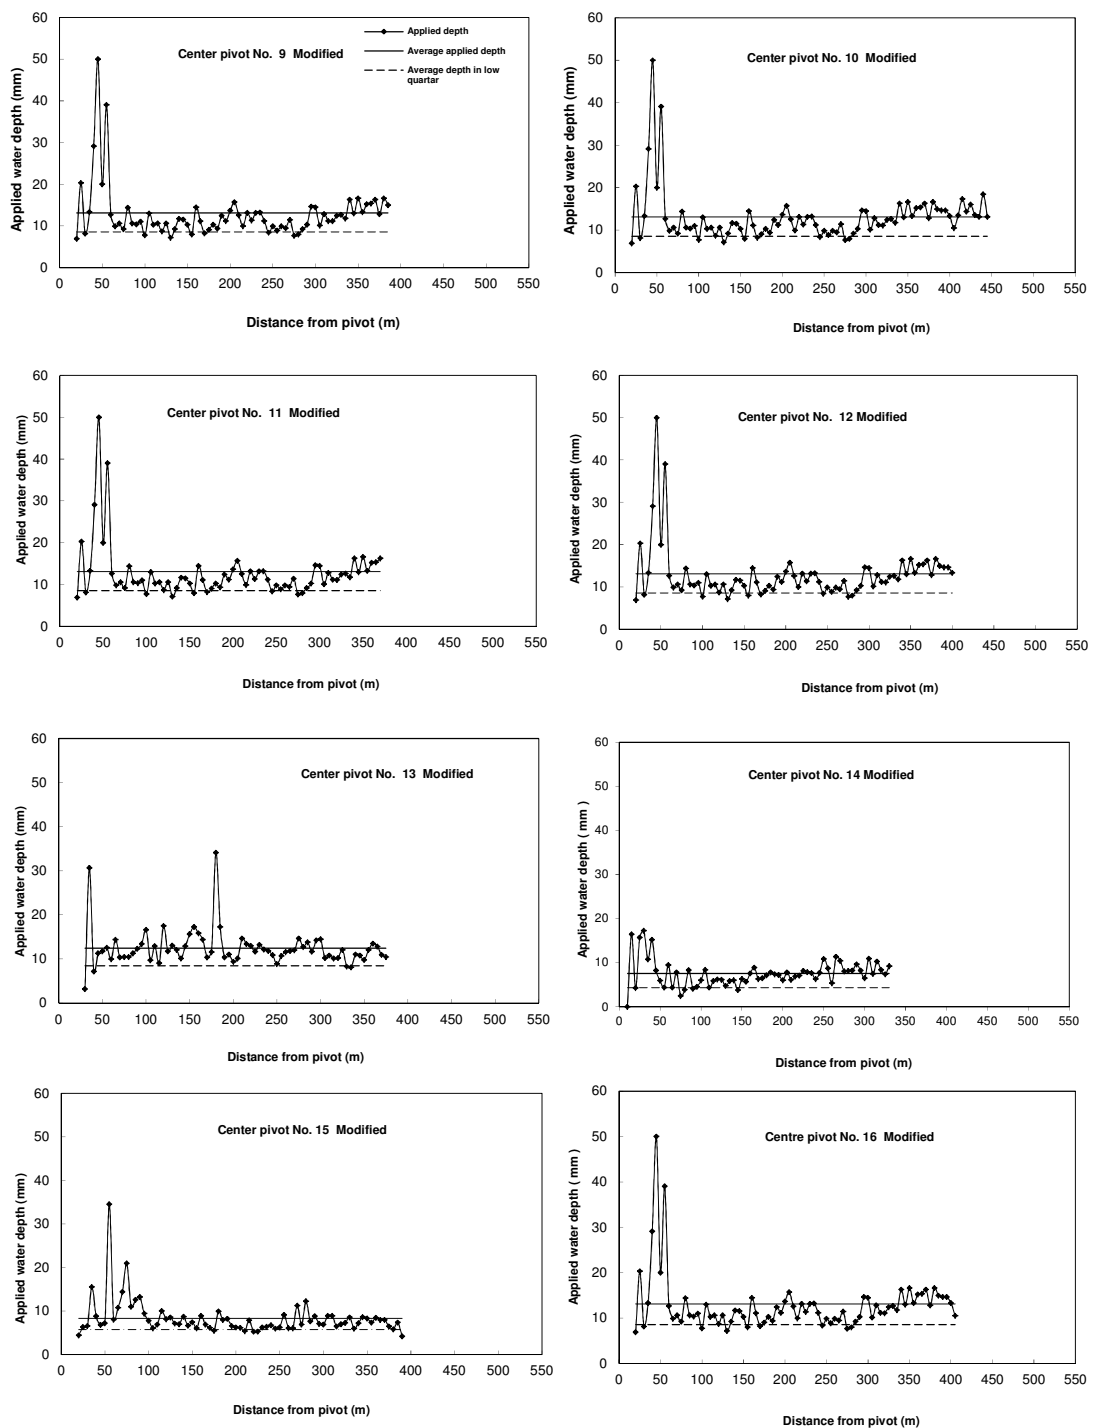
**Figure 4.** Water distribution patterns in radial direction with the average depths and the average low quarter depths of application recorded from center pivot systems with modified laterals.

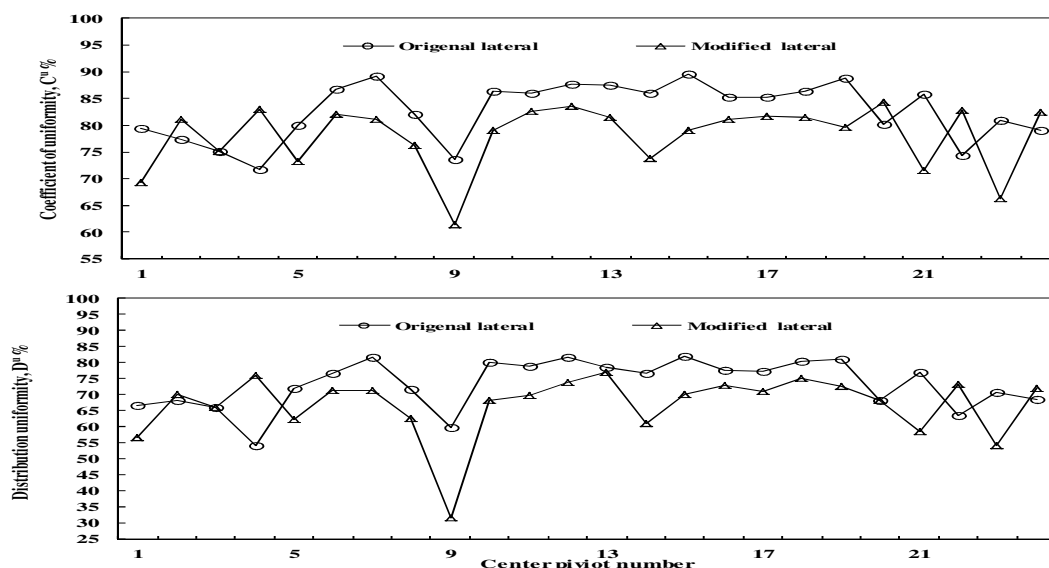
**Figure 5.** A comparison between values of coefficient of uniformity ( $Cu$ ) and distribution uniformity ( $Du$ ) for 48 of the original vs. modified center pivot systems.

To compare how well the center pivot irrigation systems applied water to the irrigated areas and to determine whether each system was operating at an acceptable uniformity, performance index values were determined and compared. This was done by calculating the values of  $Cu$  and  $Du$ , employing Equations (1) and (2) for the 48 center pivot systems. A comparison of the performance index values and the uniformity differences made between the original vs. the modified systems are shown in Figure 5. It can be seen that the index values were lower for center pivot systems with modified laterals as compared with the center pivot systems equipped with the original laterals. Also, Figure 5 shows the difference in values between  $Cu$  for original and modified laterals, the average values of  $Cu$  for original systems ranged between 71.81 and 89.46% with an average of 82.69%, whereas the average values of  $Cu$  for modified systems ranged between 61.35 and 84.33% with an overall average of 78.05%. Also, the values of  $Du$  (Figure 5) ranged between 54.14 and 81.81% with an overall average of 73.24% for the original systems. The values

of  $Du$  for the modified systems ranged between 31.45 and 77.07% with an overall average of 66.87%. This also, indicates that original center pivot systems performed more accurately and applied water more uniformly to the soil surface as compared with the modified systems.

Taking 80 and 67% as acceptable performance levels for  $Cu$  and  $Du$ , respectively, (Merriam and Keller, 1978),  $Cu$  and  $Du$  values for most of the modified systems were below acceptable levels. But for the majority of original center pivot systems, irrigation water was distributed more uniformly and most values of  $Cu$  and  $Du$  well above the 80 and 67% levels. Thus, it can be said that the performance of the original systems was better than the performance of the modified systems, and water applied more uniformly. Poor distribution uniformity and wide variations in depths of water applied along the laterals are obvious in the modified systems. This would adversely affect crop growth and yield of field crops irrigated through these center pivot systems.
