## Effect of Center Pivot System Lateral Configuration on Water Application Uniformity in an Arid Area

H. M. Al-Ghobari<sup>1</sup>

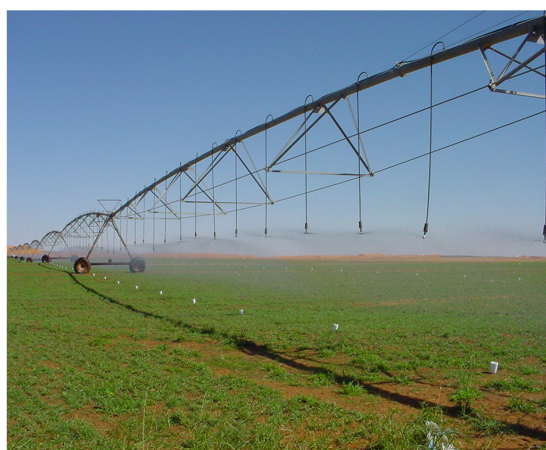
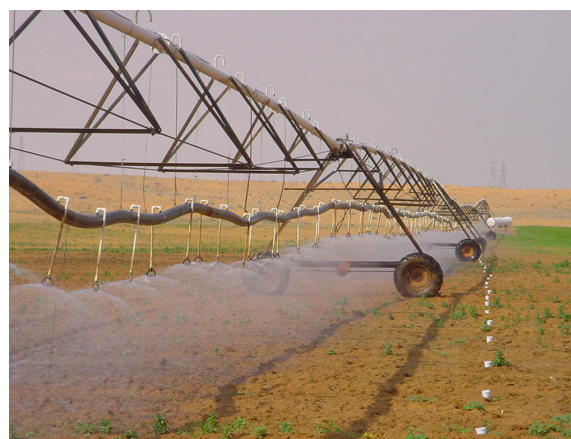
**Figure 1.** Two types of center pivot systems employed in the study with (a) original and (b) modified laterals.

The original pivot lateral (Figure 1-a) within these center pivot systems was built of galvanized steel pipe (Table 1), while the center pivot systems with modified laterals (Figure 1-b) carried a polyethylene pipe of the same diameter all through and positioned below the original lateral. The height of the modified lateral was close to the soil surface as compared with the original lateral with the new height from soil surface ranging between 1.5 and 2.0 m, and the lengths of the drop tubes connected to the modified lateral ranging from 0.5 to 1.0 m. none of the sprinklers, installed along the modified lateral were equipped with pressure regulators.

(a) Original lateral

(b) Modified lateral

were caused by an improper location of the laterals and their variations in height from the soil surface (Figure 1-b) and subsequent variations in the nozzles' pressure along the lateral. This caused the sprinkler discharge and application depth patterns along the modified laterals to be different from those in the laterals of original installments.

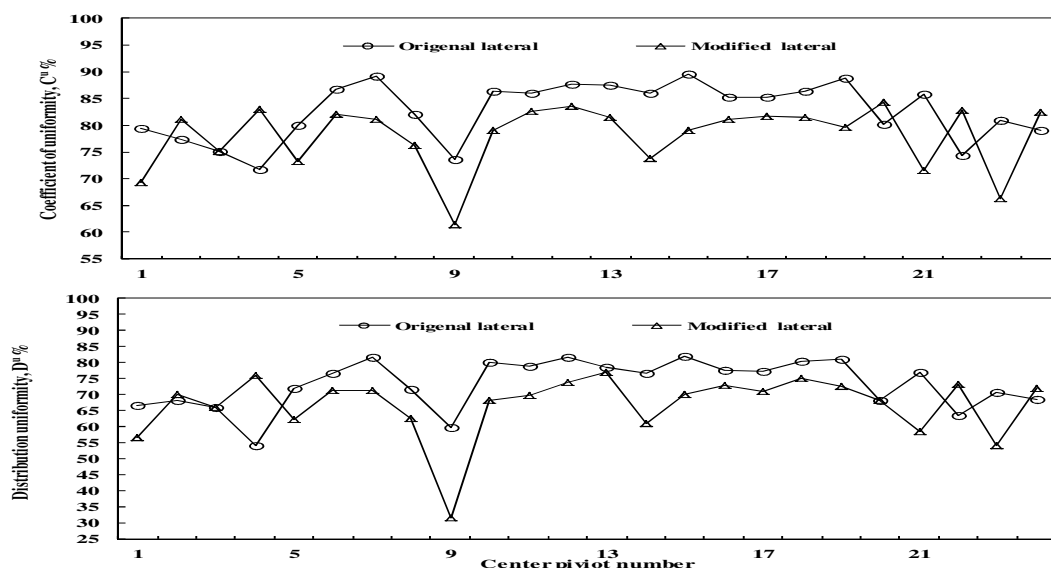
**Figure 5.** A comparison between values of coefficient of uniformity ( $Cu$ ) and distribution uniformity ( $Du$ ) for 48 of the original vs. modified center pivot systems.

To compare how well the center pivot irrigation systems applied water to the irrigated areas and to determine whether each system was operating at an acceptable uniformity, performance index values were determined and compared. This was done by calculating the values of  $Cu$  and  $Du$ , employing Equations (1) and (2) for the 48 center pivot systems. A comparison of the performance index values and the uniformity differences made between the original vs. the modified systems are shown in Figure 5. It can be seen that the index values were lower for center pivot systems with modified laterals as compared with the center pivot systems equipped with the original laterals. Also, Figure 5 shows the difference in values between  $Cu$  for original and modified laterals, the average values of  $Cu$  for original systems ranged between 71.81 and 89.46% with an average of 82.69%, whereas the average values of  $Cu$  for modified systems ranged between 61.35 and 84.33% with an overall average of 78.05%. Also, the values of  $Du$  (Figure 5) ranged between 54.14 and 81.81% with an overall average of 73.24% for the original systems. The values

of  $Du$  for the modified systems ranged between 31.45 and 77.07% with an overall average of 66.87%. This also, indicates that original center pivot systems performed more accurately and applied water more uniformly to the soil surface as compared with the modified systems.

Taking 80 and 67% as acceptable performance levels for  $Cu$  and  $Du$ , respectively, (Merriam and Keller, 1978),  $Cu$  and  $Du$  values for most of the modified systems were below acceptable levels. But for the majority of original center pivot systems, irrigation water was distributed more uniformly and most values of  $Cu$  and  $Du$  well above the 80 and 67% levels. Thus, it can be said that the performance of the original systems was better than the performance of the modified systems, and water applied more uniformly. Poor distribution uniformity and wide variations in depths of water applied along the laterals are obvious in the modified systems. This would adversely affect crop growth and yield of field crops irrigated through these center pivot systems.
