Effect of Center Pivot System Lateral Configuration on Water Application Uniformity in an Arid Area

H. M. Al-Ghobari¹

ABSTRACT

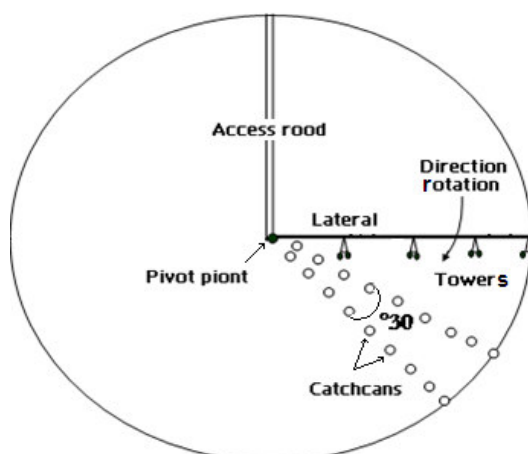
Figure 2. Field layout and schematic diagram demonstrating the distribution of catch cans.

the methodology of Merriam and Keller (1978) and ASABE Standard, S436.1 (2007). Wind speeds ranged from 1.5 to 6.3 m s⁻¹, the air temperature from 17 to 30°C, and while the relative humidity varying between 28 and 57 %. Two rows of catch cans were used in each system to measure the uniformity of water distribution in the radial direction as shown in Figure 2. The catch can spacing was chosen 5 m with the first can at 11.6 m from the pivot point (Merriam and Keller, 1978). Catch cans of 16 cm inside diameters and 15 cm heights were made use of. The catch cans were placed along a line extending radially from the pivot point. The two lines were sufficiently distanced apart from the pipeline to allow for the system to allow for the testing conditions. The operating speed of

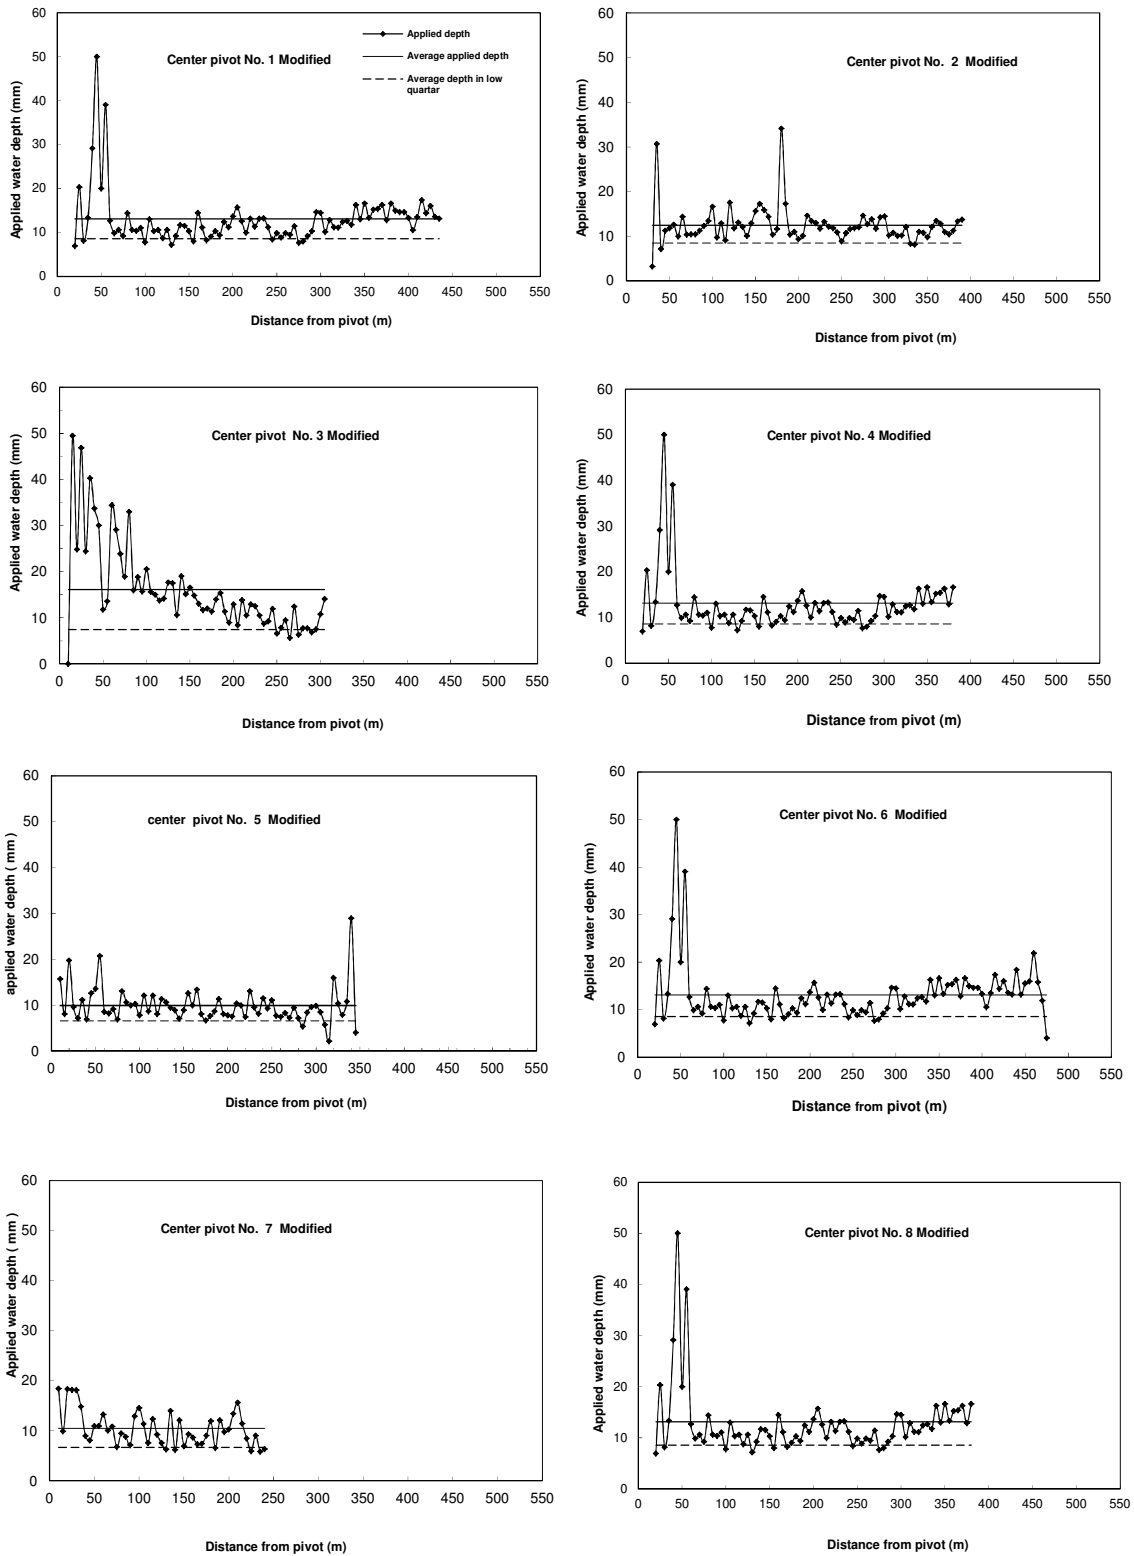
(a)

Figure 4. Water distribution patterns in radial direction with the average depths and the average low quarter depths of application recorded from center pivot systems with modified laterals.

Water application uniformity is a measure of how evenly water is spread over the soil surface during irrigation under different field operating conditions. Water distribution profiles along the laterals of the tested center pivot systems are shown in Figures 3 (a and b) and 4 (a and b) for original and modified laterals, respectively. The profiles depict water depths caught in each can along the lateral for each of the 32 center pivot

systems. The figures show that substantial areas of the center pivot systems were receiving less than the average amount of water applied and there was substantial variation in depth of water applied along the lateral from one system to another, especially for center pivot systems with modified laterals. Average depths and average low quarter depths of application for each system were determined and displayed (Figures 3 and 4). Average depths and the low quarter average depths of application for 24 center pivot systems equipped with original laterals ranged from 24.33 to 4.31 mm, and from 17.42 to 2.33 mm respectively, whereas, the average depths and the low quarter average depths of application for the 24 modified systems (Figure 4) ranged from 13.23 to 5.23 mm and from 9.36 to 3.59 mm respectively. It can be seen that both depth values for the original systems were higher than those for modified systems. This indicates that more water was applied through the original center pivot systems to the irrigated areas as compared with the center pivot systems with modified laterals and when at the same travel speed. The lower depth values were attributed to lateral configurations changes made by farmers, bringing about pressure variations, improper nozzling, inaccurate water patterns and as well leakage along the laterals.

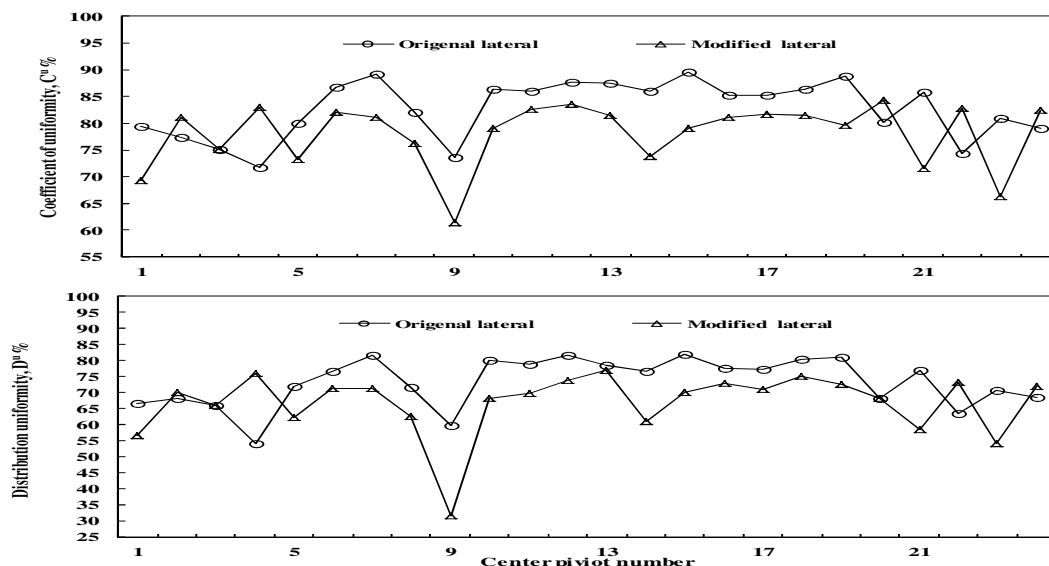
Figure 5. A comparison between values of coefficient of uniformity (C_u) and distribution uniformity (D_u) for 48 of the original vs. modified center pivot systems.

To compare how well the center pivot irrigation systems applied water to the irrigated areas and to determine whether each system was operating at an acceptable uniformity, performance index values were determined and compared. This was done by calculating the values of C_u and D_u , employing Equations (1) and (2) for the 48 center pivot systems. A comparison of the performance index values and the uniformity differences made between the original vs. the modified systems are shown in Figure 5. It can be seen that the index values were lower for center pivot systems with modified laterals as compared with the center pivot systems equipped with the original laterals. Also, Figure 5 shows the difference in values between C_u for original and modified laterals, the average values of C_u for original systems ranged between 71.81 and 89.46% with an average of 82.69%, whereas the average values of C_u for modified systems ranged between 61.35 and 84.33% with an overall average of 78.05%. Also, the values of D_u (Figure 5) ranged between 54.14 and 81.81% with an overall average of 73.24% for the original systems. The values

of D_u for the modified systems ranged between 31.45 and 77.07% with an overall average of 66.87%. This also, indicates that original center pivot systems performed more accurately and applied water more uniformly to the soil surface as compared with the modified systems.

Taking 80 and 67% as acceptable performance levels for C_u and D_u , respectively, (Merriam and Keller, 1978), C_u and D_u values for most of the modified systems were below acceptable levels. But for the majority of original center pivot systems, irrigation water was distributed more uniformly and most values of C_u and D_u well above the 80 and 67% levels. Thus, it can be said that the performance of the original systems was better than the performance of the modified systems, and water applied more uniformly. Poor distribution uniformity and wide variations in depths of water applied along the laterals are obvious in the modified systems. This would adversely affect crop growth and yield of field crops irrigated through these center pivot systems.
