Erosion Risk Mapping Using CORINE Methodology for Goz Watershed in Kahramanmaras Region, Turkey

M. Reis^{1*}, A. E. Akay², and G. Savaci³

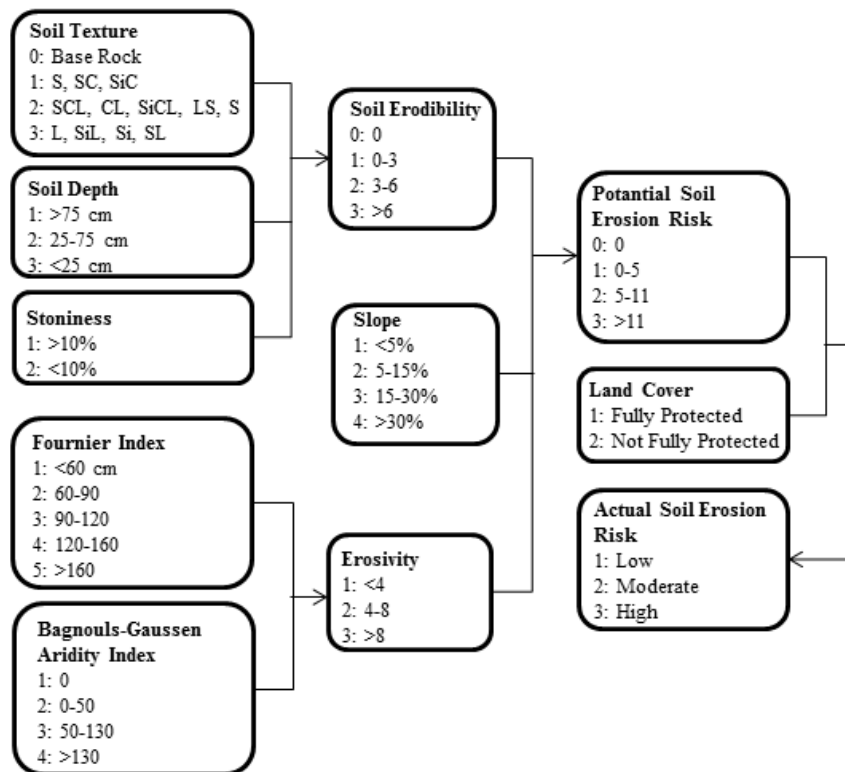
Figure 3. Flow diagram of the CORINE methodology (C: Clay; S: Sandy; Si: Silt, L: Loam).

In the CORINE methodology, soil texture was grouped into three classes including: Slightly erodible (1), Moderately erodible (2), and Highly erodible (3) (Figure 3). Soil maps were used in order to classify soil stoniness and soil depth, which are important indicators of erosion. The stoniness was classified as: Fully protected (1), and Not fully protected (2) soils, by considering the percentage surface cover of stones. The soil depth, which is the depth from the soil surface to the base of the soil profile, was classified as slightly erodible (>75 cm) (1), moderately erodible (25-75 cm) (2), and highly erodible (<25 cm) (3) soils. Finally, the soil erodibility index was calculated by multiplying these three soil factors (CORINE, 1992; Bayramin *et al.*, 2003; Aydın and Tecimen, 2010) and reclassified

Where, T_i is the mean temperature for the month, P_i is the total precipitation for month, and k_i is the proportion of the month during which $2T_i - P_i > 0$. The *BGI* was classified into: Humid (1), Moist (2), Dry (3), and Very dry (4). Finally, erosivity index was determined by multiplying Fournier and Bagnouls-Gausson aridity indices. The input data of precipitation and temperature were obtained from the nearest weather station in Kahramanmaraş for the period of 1985-2010. Finally, erosivity index was reclassified into: Low (1), Moderate (2), and High (3) (Figure 3).

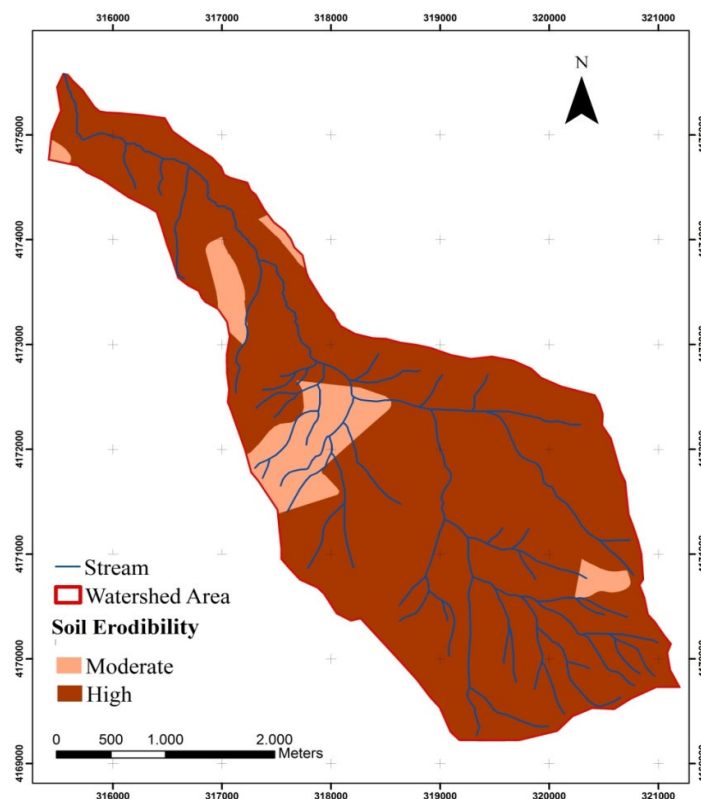
Figure 4. The soil erodibility map of the study area.

Based on soil texture, stoniness, and depth parameters, erodibility factor was moderate (3-6) in 9.5% (126.81 ha) of the total area while it was classified as high (> 6) in 90.5% (1207.98 ha) of the area. Thus, the soil in most parts of the study area was subject to erosion risk considering soil erodibility factor (Figure 4).

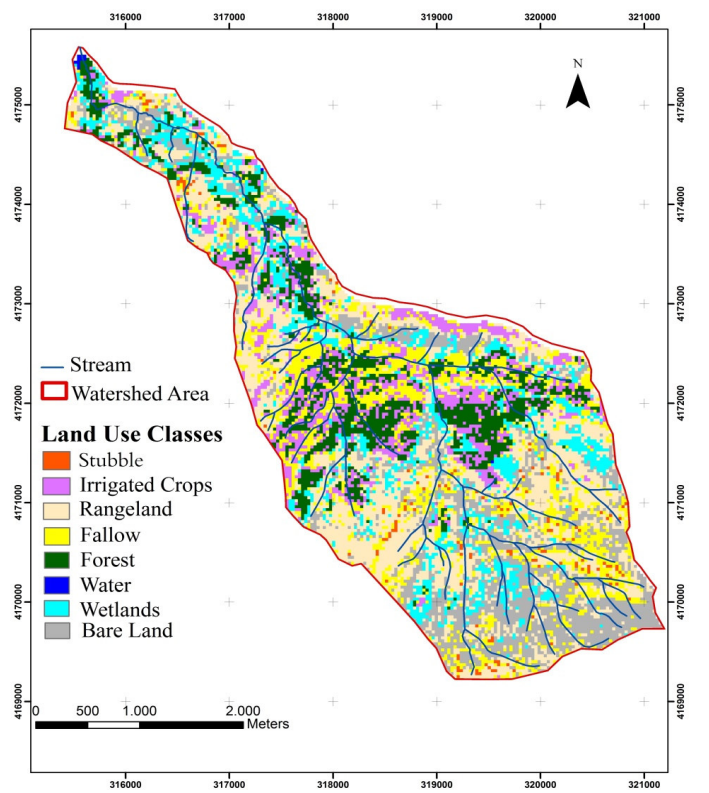
Figure 7. Land use map of the study area.

the classified image indicated that classification process provided overall accuracy of 85.71%. The land cover layer was reclassified into two vegetation indices including fully protected and not fully protected based on CORINE methodology.

In the study area, forest was classified as fully protected (1), while the rest i.e. irrigated crops, stubble, fallow, wetlands, rangeland, and bare land were classified as not-fully protected (2). Land cover map indicated that the study area was 88.33% not-fully and 11.67% was fully protected. Actual erosion risk map indicated that 11.97% of the study area had moderate risk, while 88.03% of the study area possesses high erosion risk (Figure 8).
